# Kirby Road Environmental Assessment

## Tree Protection Plan

Project No. 2339A | August 2021

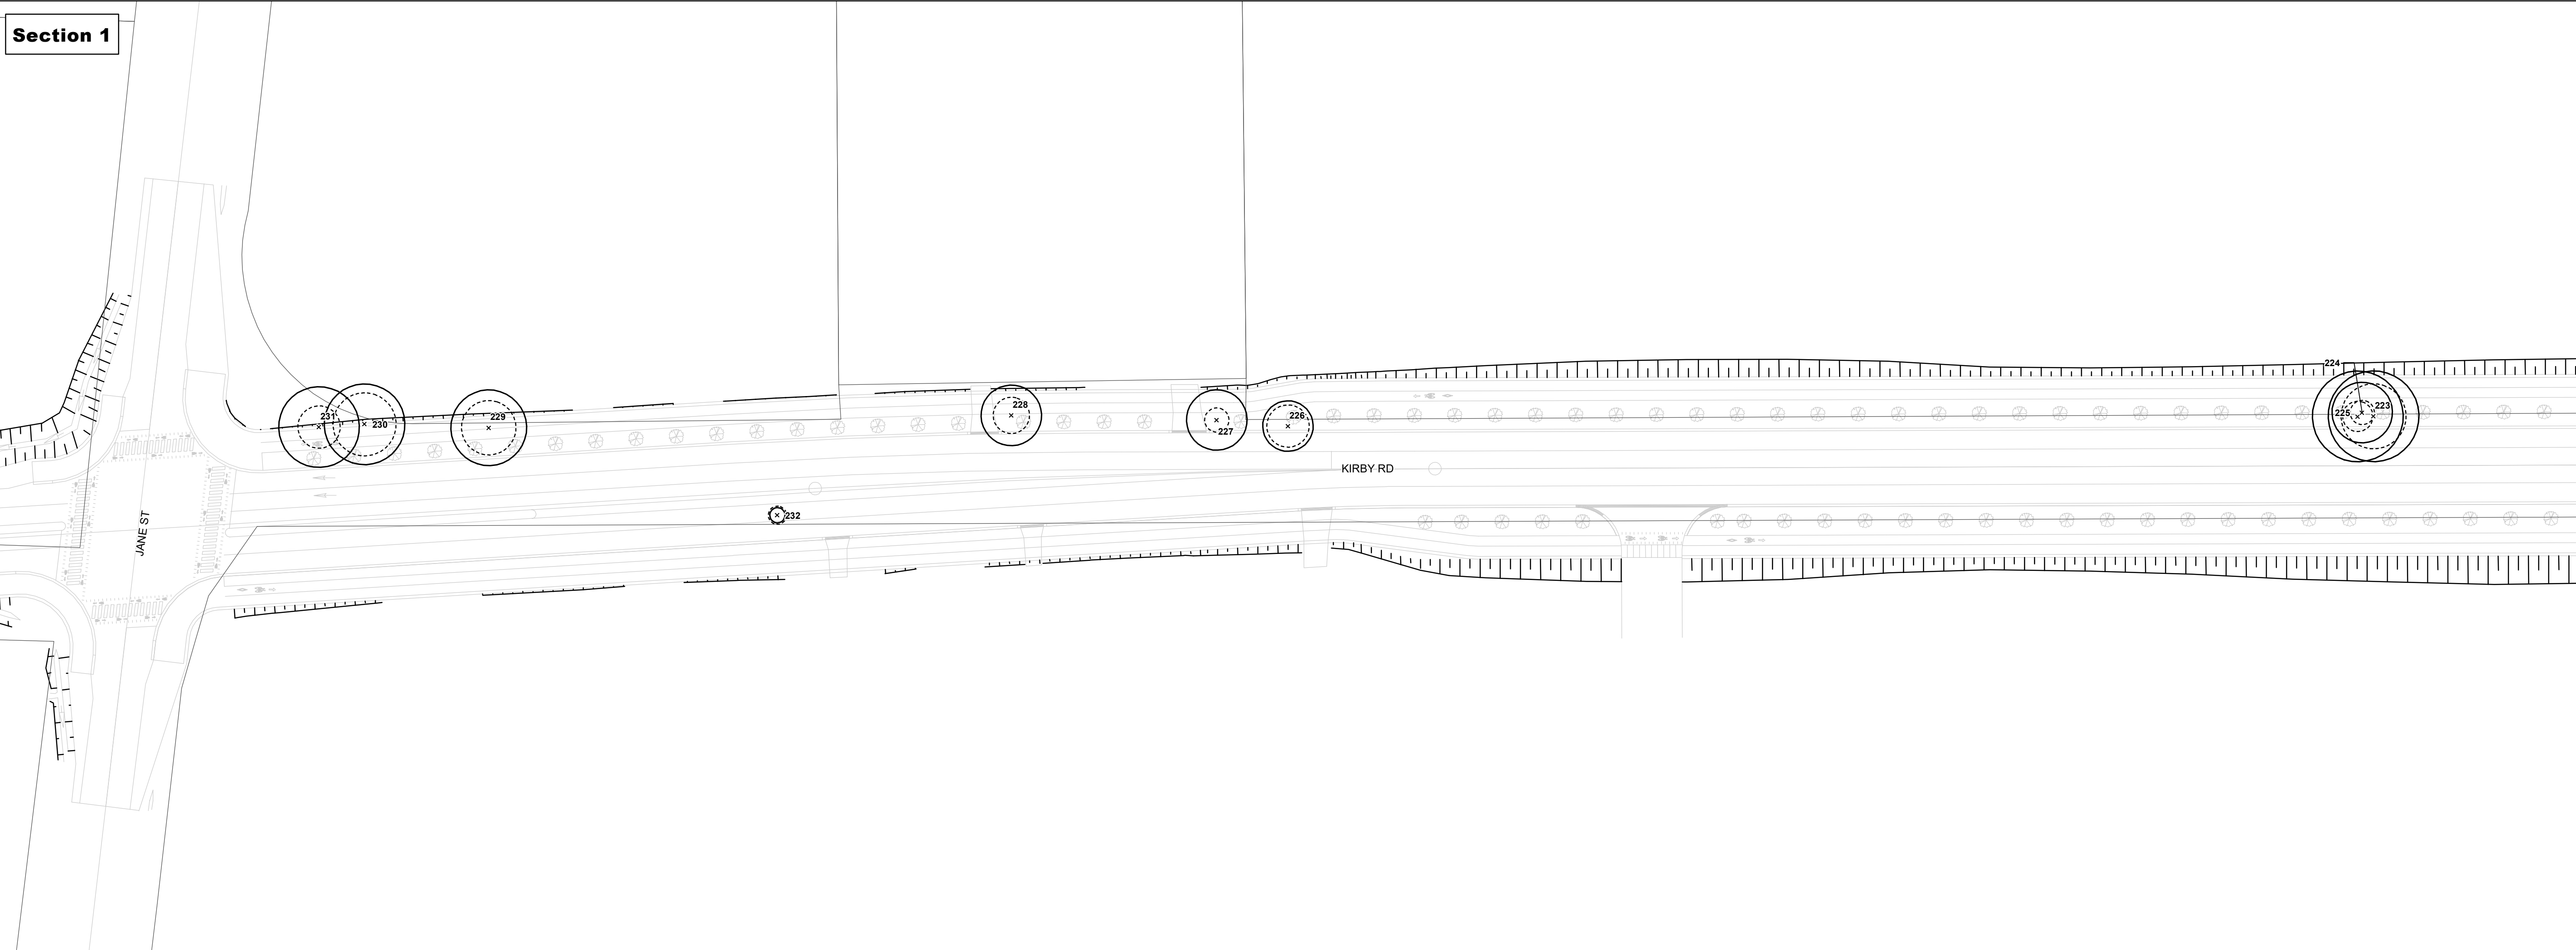
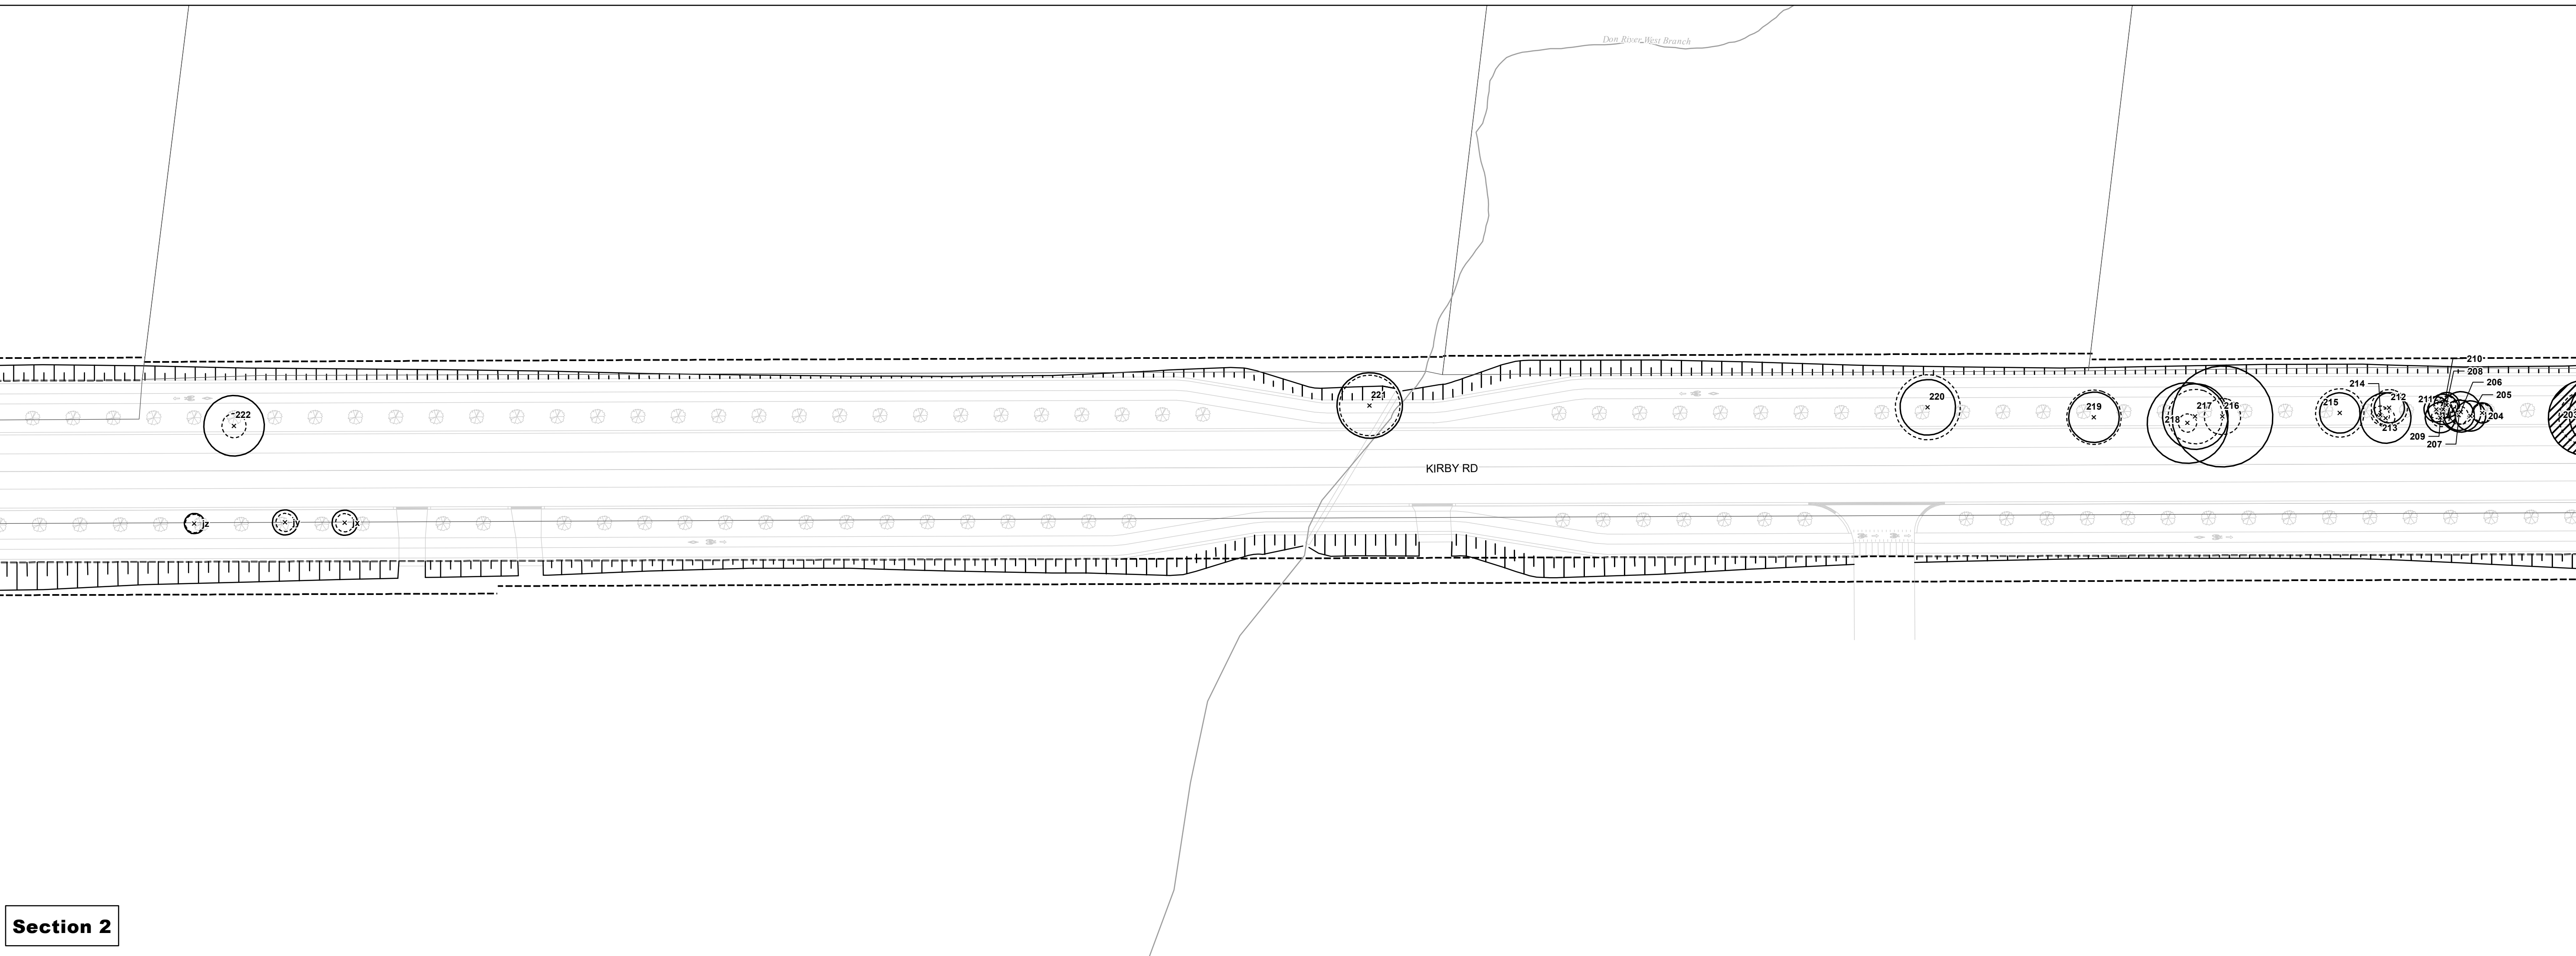
**Map 1a**

Trees with features suitable for maternal roosting habitat for SAR bats are identified on Map 1. Consultation with the Ministry of the Environment, Conservation, and Parks (MECP) may be required to determine mitigation actions for habitat trees that are identified for removal to accommodate the planned road improvement works. Please refer to the Environmental Impact Study report (NRSI 2021) for additional details about SAR bat habitat and mitigation recommendations.
