Kirby Road Widening Environmental Assessment (Jane Street to Dufferin Street)

Fluvial Geomorphological Assessment Don River West Branch and East Humber River

January 10, 2020 (Updated September 15, 2021)
PN19109

Project Number: PN19109
Status: Final
Version: 1.0
First Submission Date: January 10, 2020
Revision Date: September 15, 2021

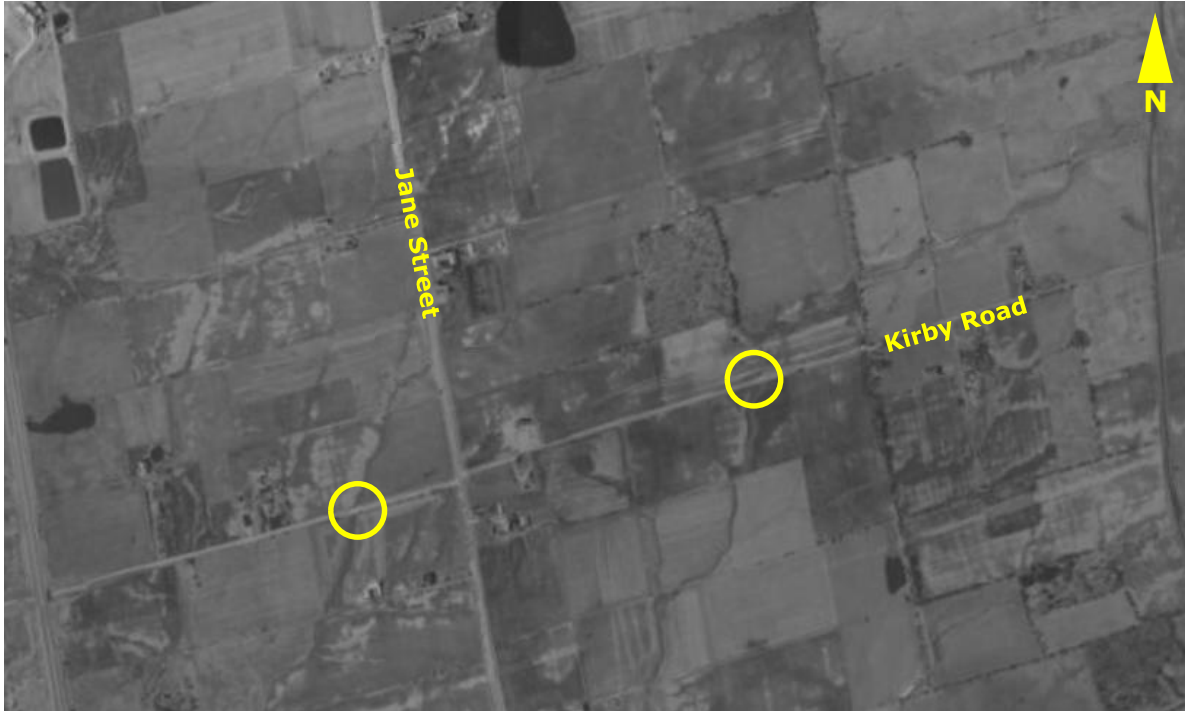
Location: Kirby Road (west)

Year: 1978

The overall land use remained agricultural by 1978. Highway 400 had since been built to the west of the study site. The upstream section of Crossing 1 appeared to have been straightened for agricultural purposes. No other changes were noted.

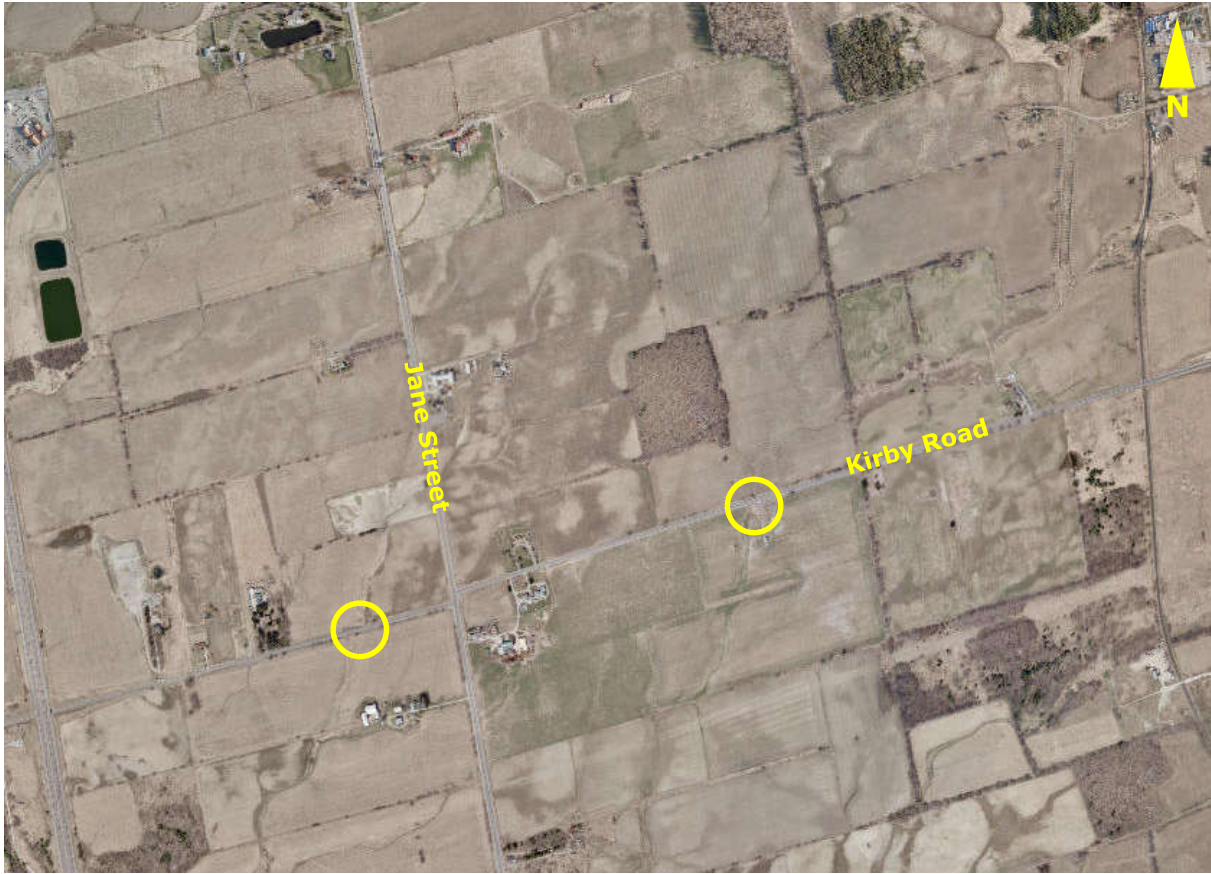
Location: Kirby Road (west)

Year: 2009

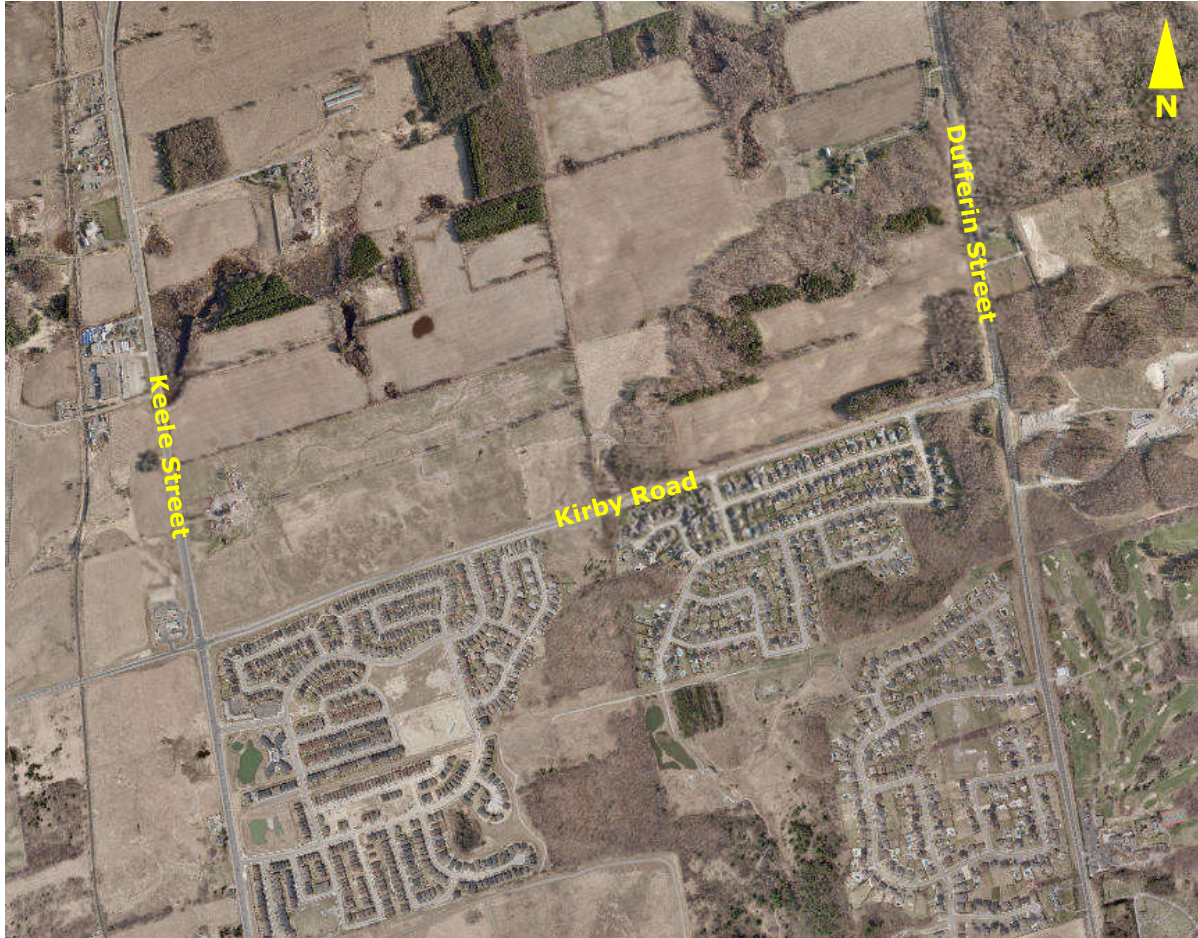
Location: Kirby Road (east)

Year: 2009

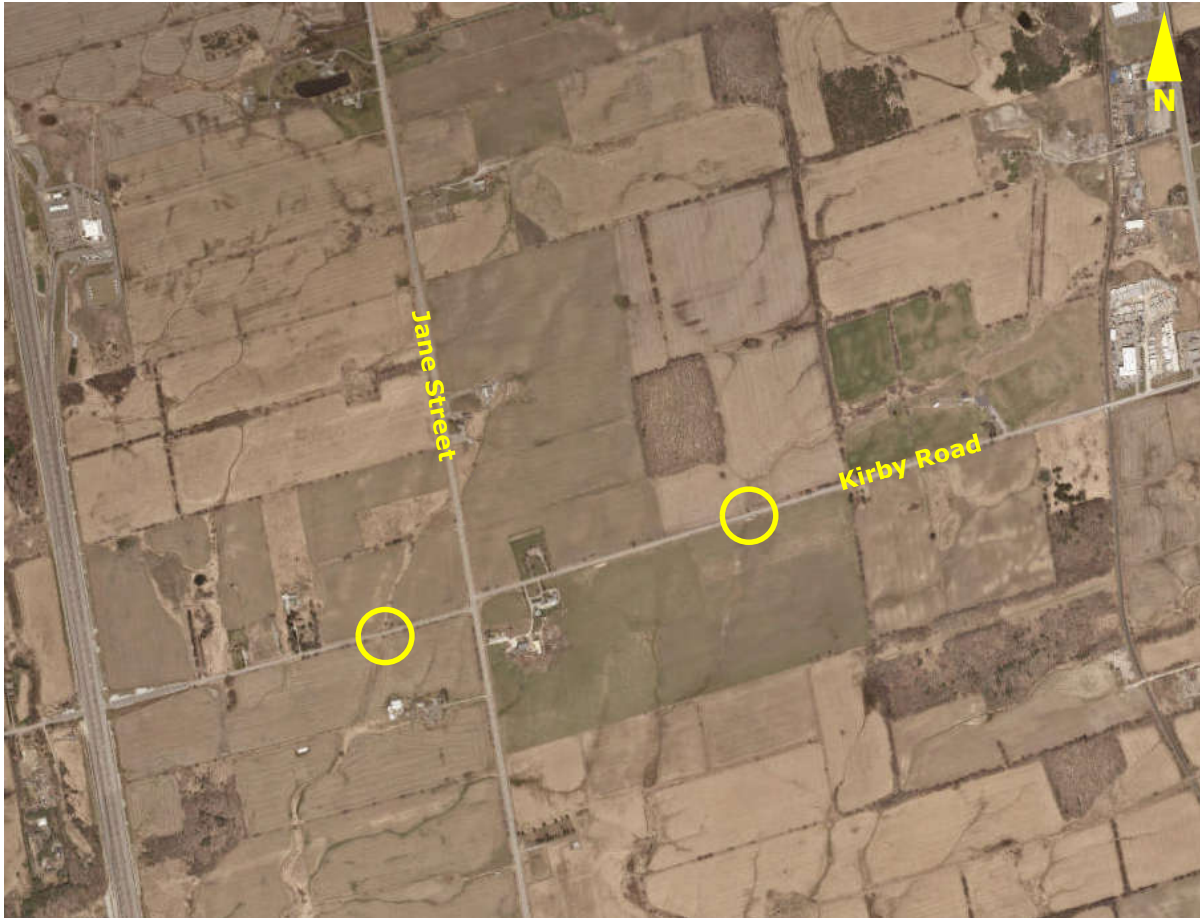
Location: Kirby Road (west)

Year: 2019

Between 2009 and 2019, land use remained mostly agricultural. However, industrial buildings had been built at the northwest corner of Keele Street and Kirby Road in vicinity of a tributary of the Don River West Branch. The industrial buildings did not appear to result in the removal of any riparian vegetation or require realignment of the adjacent tributary. Also, the weather station south of Crossing 2 was removed during this time. Upstream of Crossing 1, more trees were noted within the riparian zone, likely improving local channel conditions by providing shade and coarse particulate organic matter to the channel. The remainder of the reaches have remained similar since 2009.

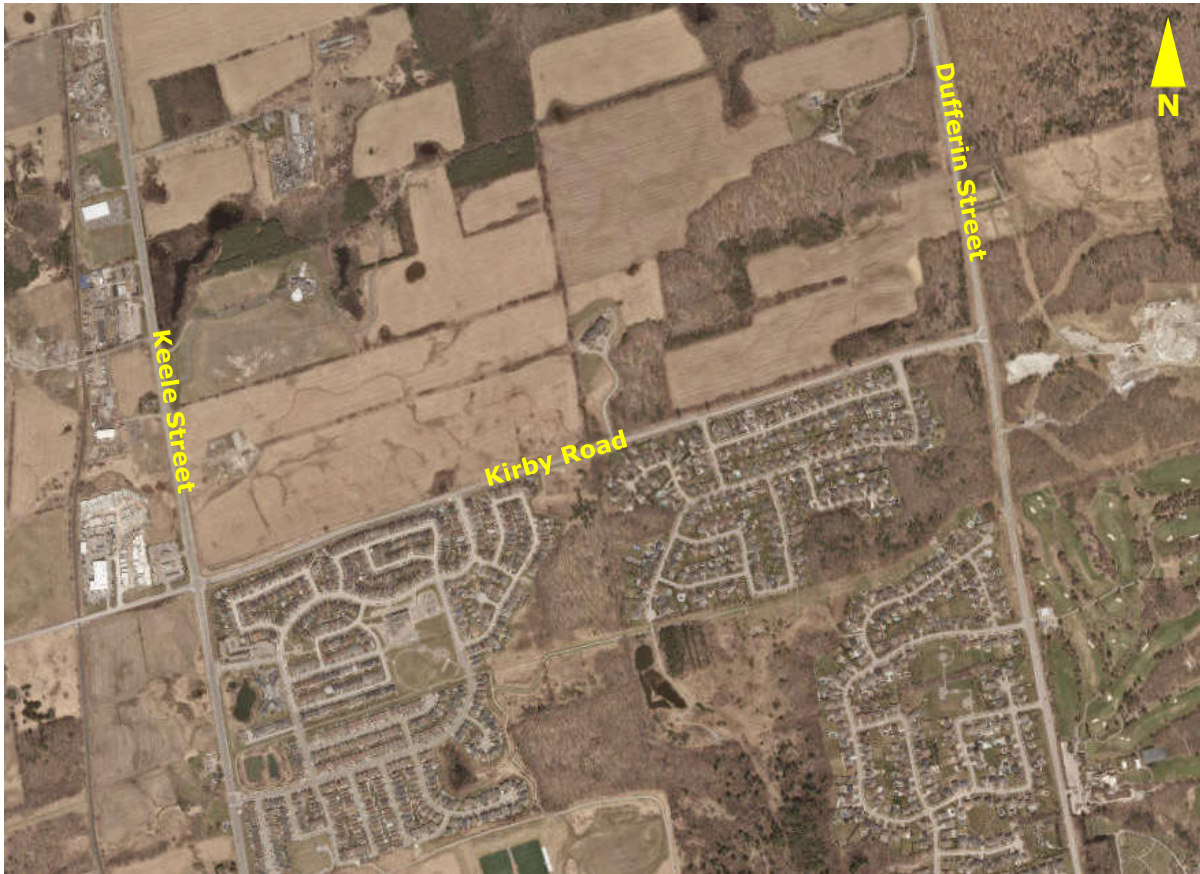
Location: Kirby Road (east)

Year: 2019

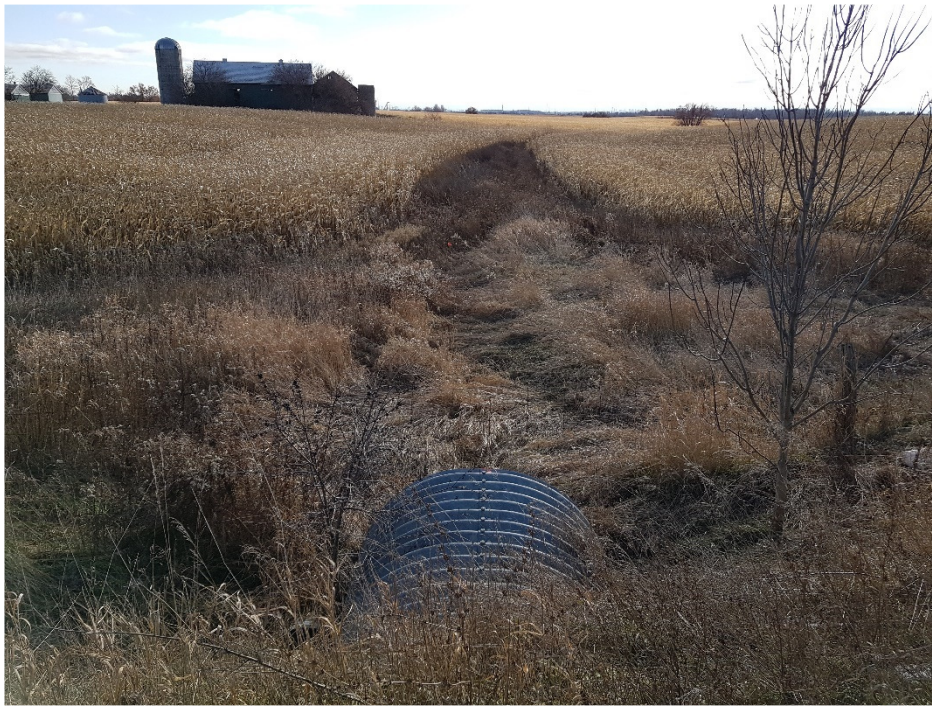
Photo 1
Crossing 1: Humber River Tributary, Reach HT2-1

Photograph taken facing downstream (south) of Kirby Road.
The swale feature flowed through an active agricultural field.

Reach **HT2-1** extended downstream (south) of Kirby Road through an agricultural field. The reach was unconfined with a low gradient. The riparian vegetation consisted of grasses and was continuous but narrow. Although bankfull indicators were generally absent, a low flow channel within the wider swale feature was observed at the fence line. The width and depth of the low flow channel were 0.4 m and 0.15 m, respectively. The swale was extensively encroached with grasses and no erosion was observed. The feature was dry at the time of assessment. The crossing consisted of a Corrugated Steel Pipe (CSP) with a diameter of 2.0 m and was stable at the time of assessment.

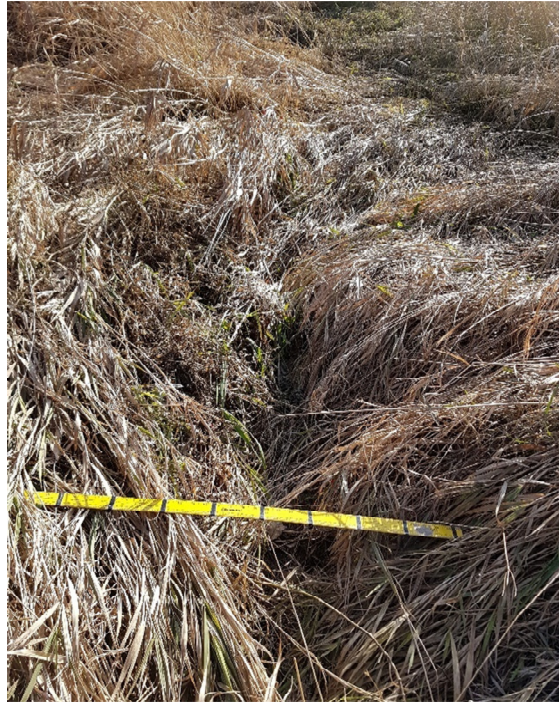
Photo 2
Crossing 1: Humber River Tributary, Reach HT2-1

Photograph taken facing downstream (south) of Kirby Road.
A defined low flow feature was observed only at the fence line.

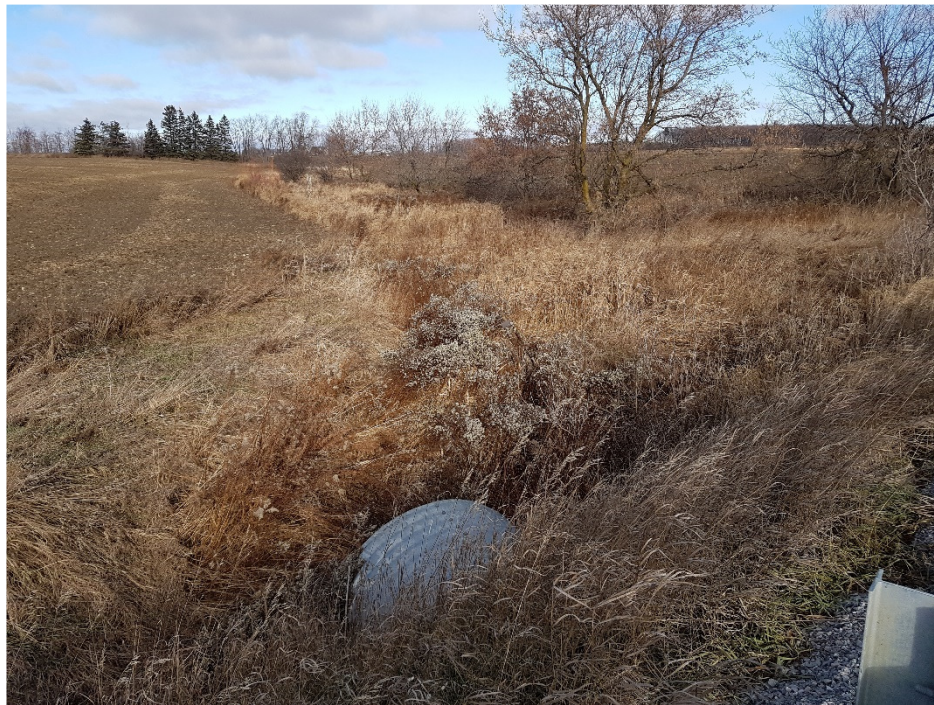
Photo 3
Crossing 1: Humber River Tributary, Reach HT2-2

Photograph taken facing upstream (north) of Kirby Road.
The swale feature flowed through an active agriculture field.

Reach **HT2-2** extended upstream (north) of Kirby Road through an agricultural field. The reach was unconfined with a low to moderate gradient. The reach appeared moderately entrenched upstream of the ROW, but no erosion was observed. The riparian buffer zone consisted of grasses with scattered trees that formed a continuous buffer. Grasses heavily encroached the reach. Similar to upstream, a low flow channel was observed within the wider swale feature. The width and depth of the low flow channel were 0.35 m and 0.10 m, respectively. The feature was dry at the time of assessment, however standing water was noted within the CSP.

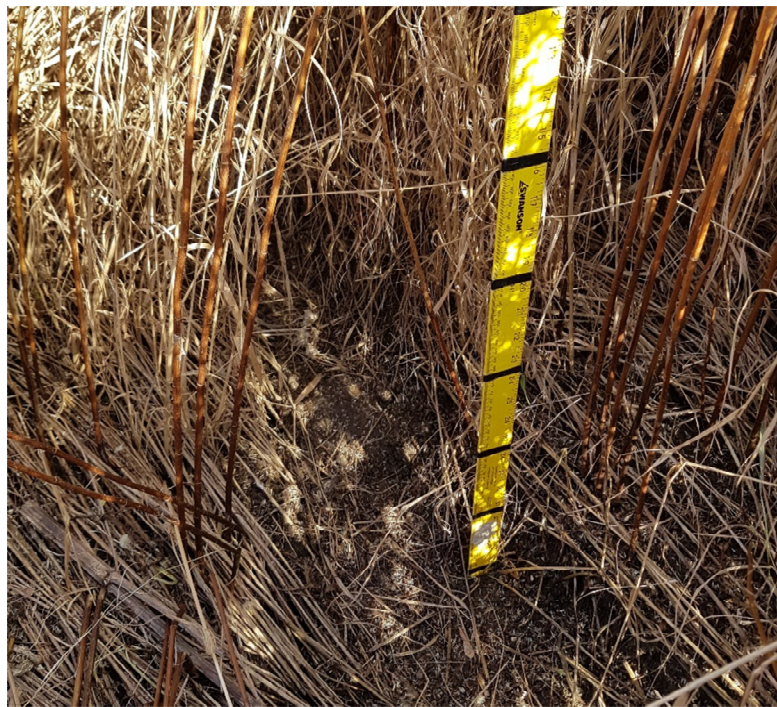
Photo 4
Crossing 1: Humber River Tributary, Reach HT2-2

Photograph taken facing upstream (north) of Kirby Road.
A defined low flow feature within the wider swale was observed.

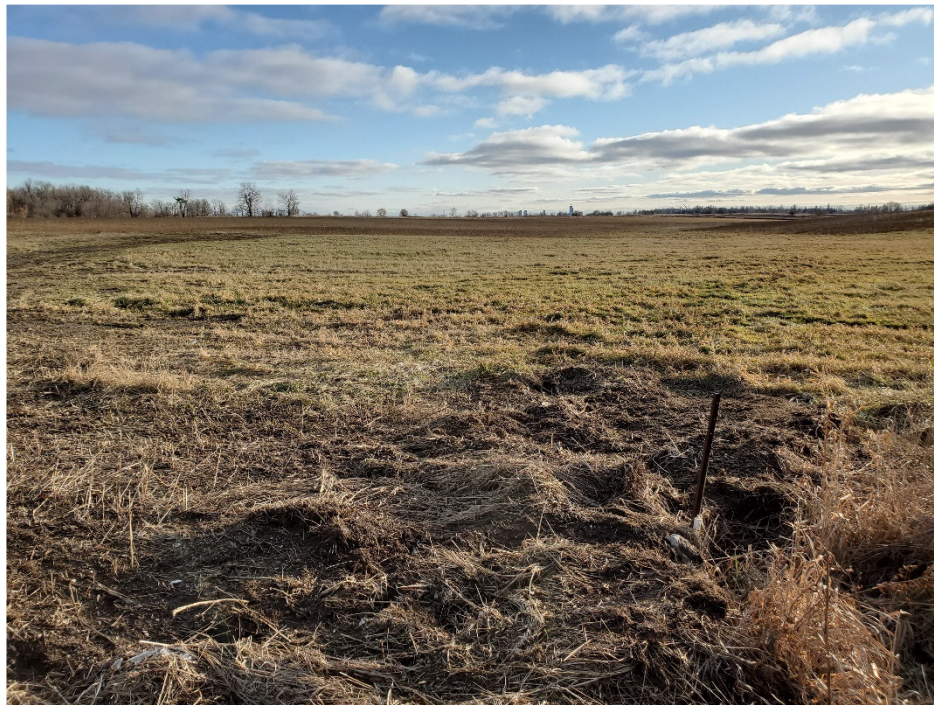
Photo 5
Crossing 2: West Don River Tributary, Reach WDT1-1

Photograph taken facing downstream (south) of Kirby Road.
No defined feature was observed.

Reach **WDT1-1** extended downstream (south) of Kirby Road. There was no defined feature (no swale or flow path) apparent through the agricultural field. There was also no riparian vegetation. The feature was dry at the time of assessment. The crossing consisted of double CSPs with a diameter of 0.6 m and was stable at the time of assessment.

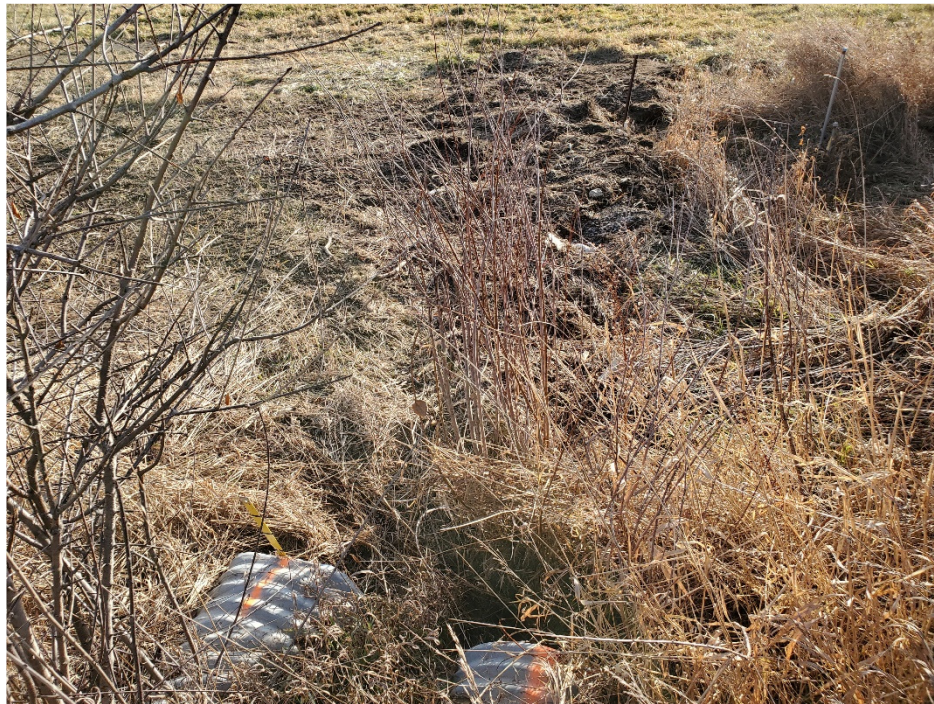
Photo 6
Crossing 2: West Don River Tributary, Reach WDT1-1

Photograph taken facing downstream (south) of Kirby Road.
Double CSPs were noted crossing Kirby Road.

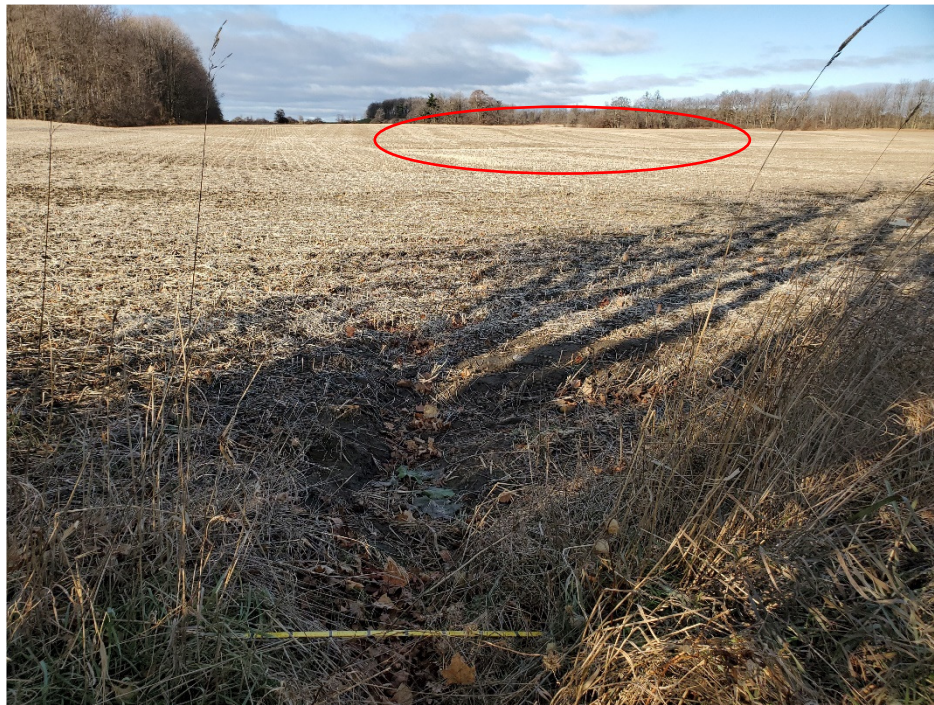
Photo 7
Crossing 2: West Don River Tributary, Reach WDT1-2

Photograph taken facing upstream (north) of Kirby Road. No defined feature was observed through agricultural field. However, a small depression further upstream was noted.

Reach **WDT1-2** extended upstream (north) of Kirby Road. A defined feature was only apparent for a few metres between Kirby Road and the edge of the agricultural field. The defined feature within the ROW had a width of 0.8 m and a depth of 0.25 m. There was no defined feature upstream through the agricultural field, however a shallow depression was observed from a distance through the agricultural field. There was also no riparian vegetation through the ploughed agricultural field. The feature was dry at the time of assessment.

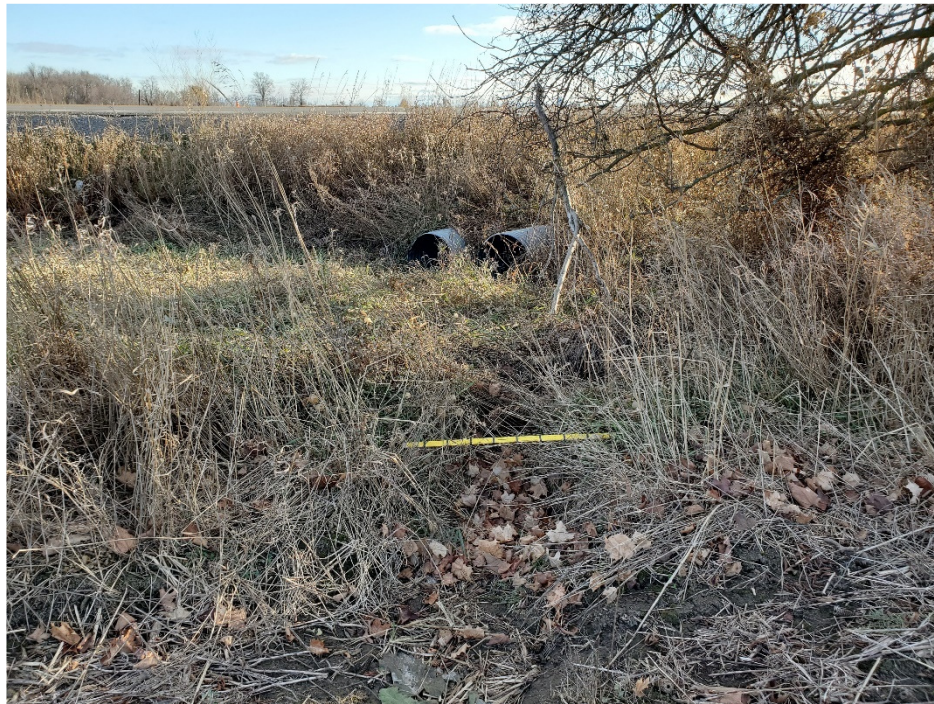
Photo 8
Crossing 2: West Don River Tributary, Reach WDT1-2

Photograph taken facing downstream (south) towards the double CSPs at Kirby Road. There was a small defined channel between the agricultural field and the CSPs.

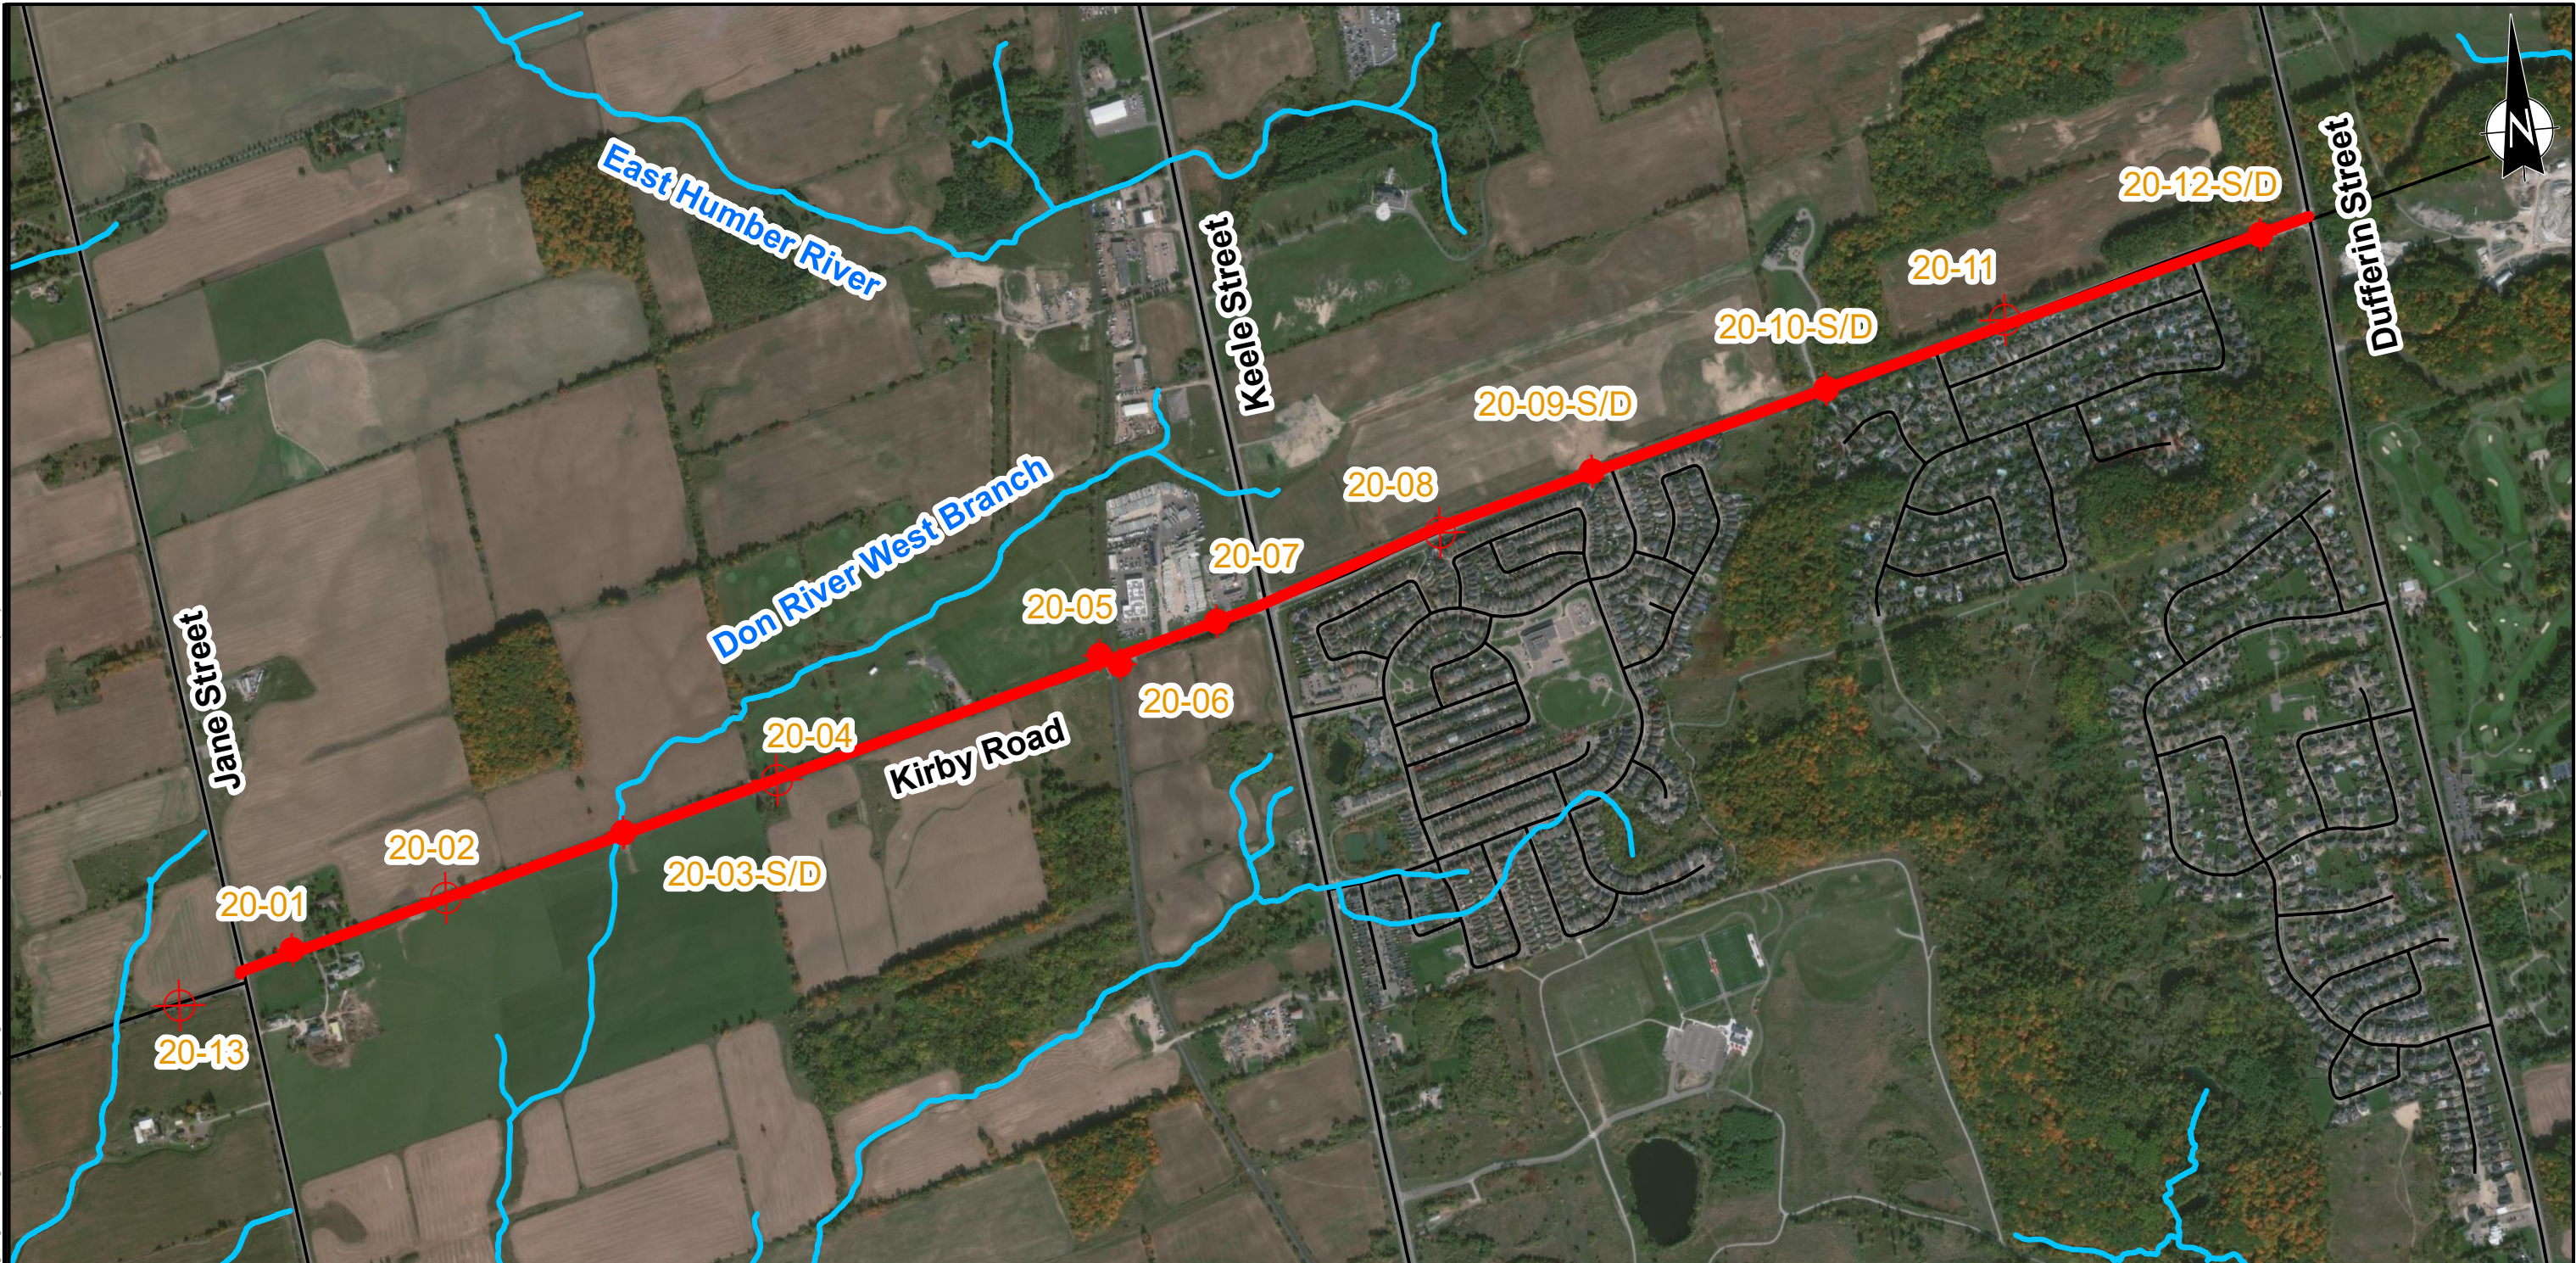
FIGURE 1

H:\20000-26130-26130 Kirby Road EA Reports & Memoirs\hydrogeological investigation\Report\Figures\GIS\Figure 9 Borehole and Monitoring Well Locations_v2.mxd modified 2020-11-20 by alnejazi

Groundwater monitoring was conducted by Thurber staff on a bi-monthly basis from July 2020 to June 2021 (Table 1 and Table 2 in Appendix A). In addition, eight (8) level loggers were instrumented in selected monitoring wells to record groundwater levels on an hourly basis, to measure seasonal groundwater fluctuations. A barologger was also installed to record barometric pressure to correct level logger readings for atmospheric pressure. A map illustrating the location of the monitoring wells is provided on Figure 1. Table 1 and Table 2 summarize the recorded groundwater levels from all on-site monitoring wells. Hydrographs of these groundwater data are provided in Appendix A.

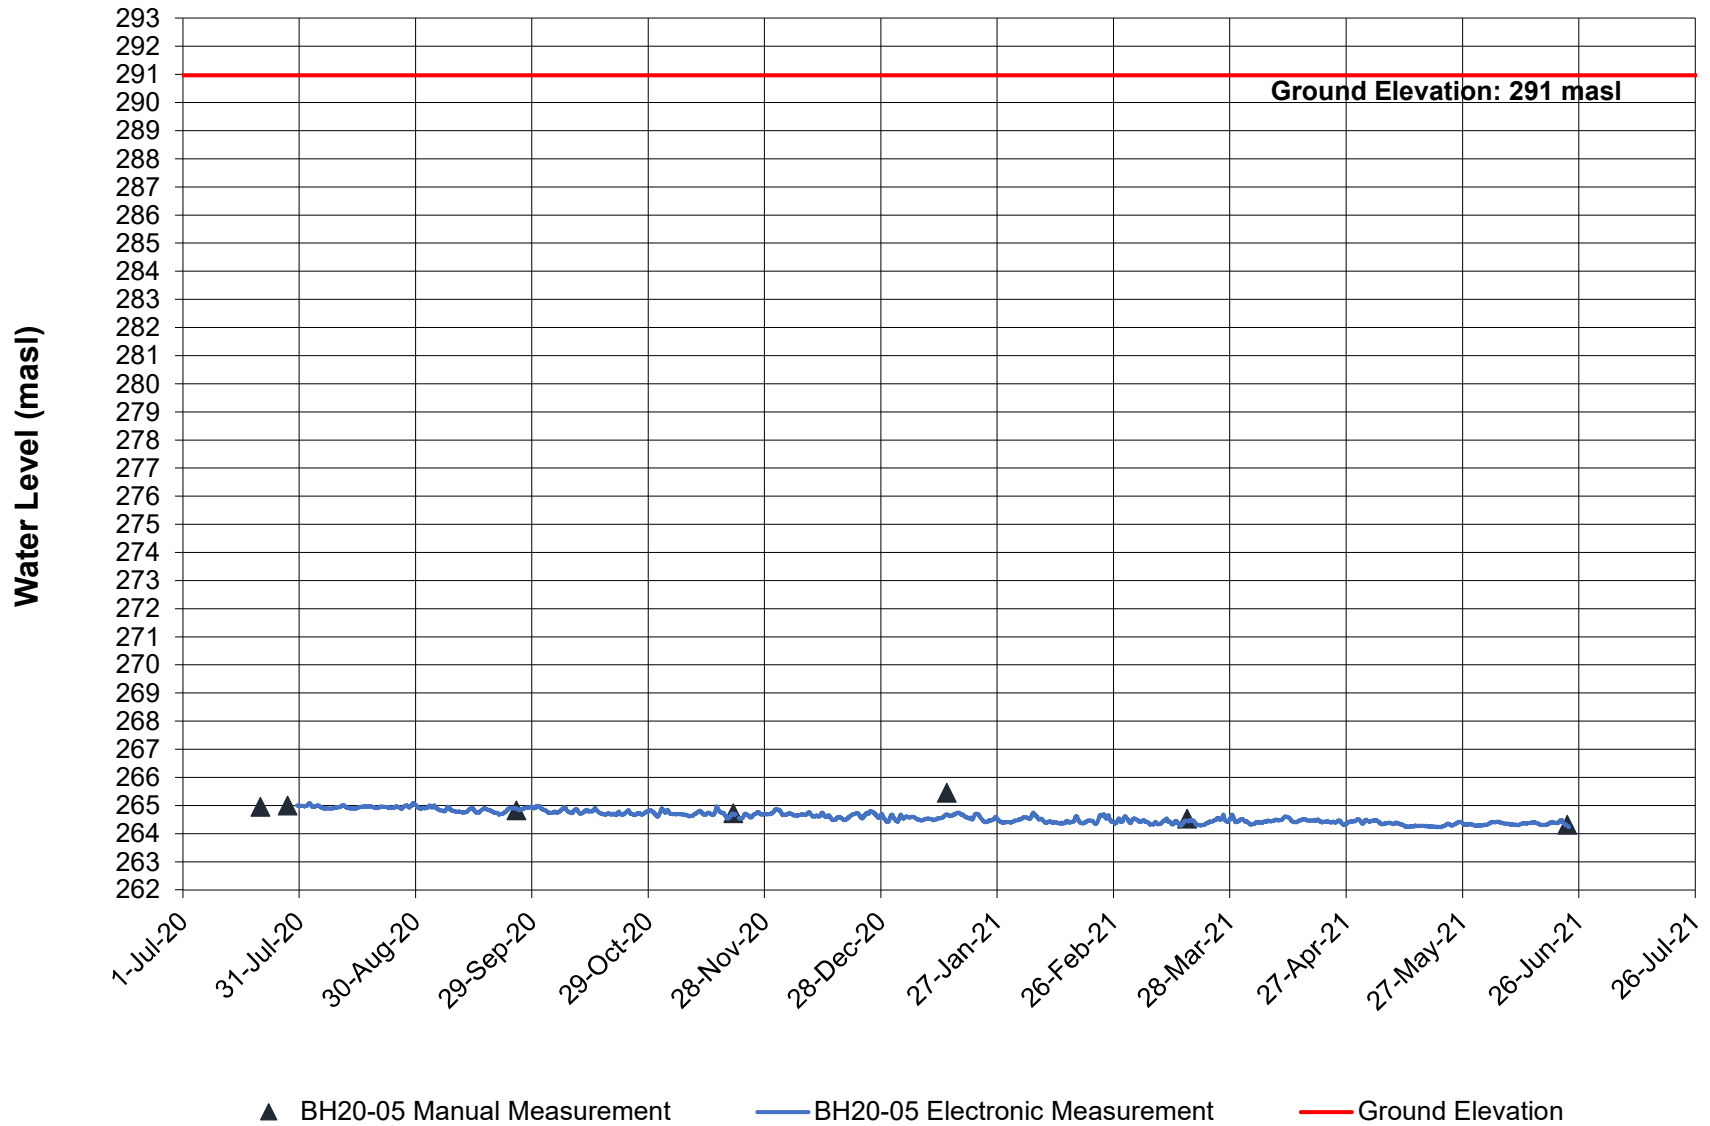
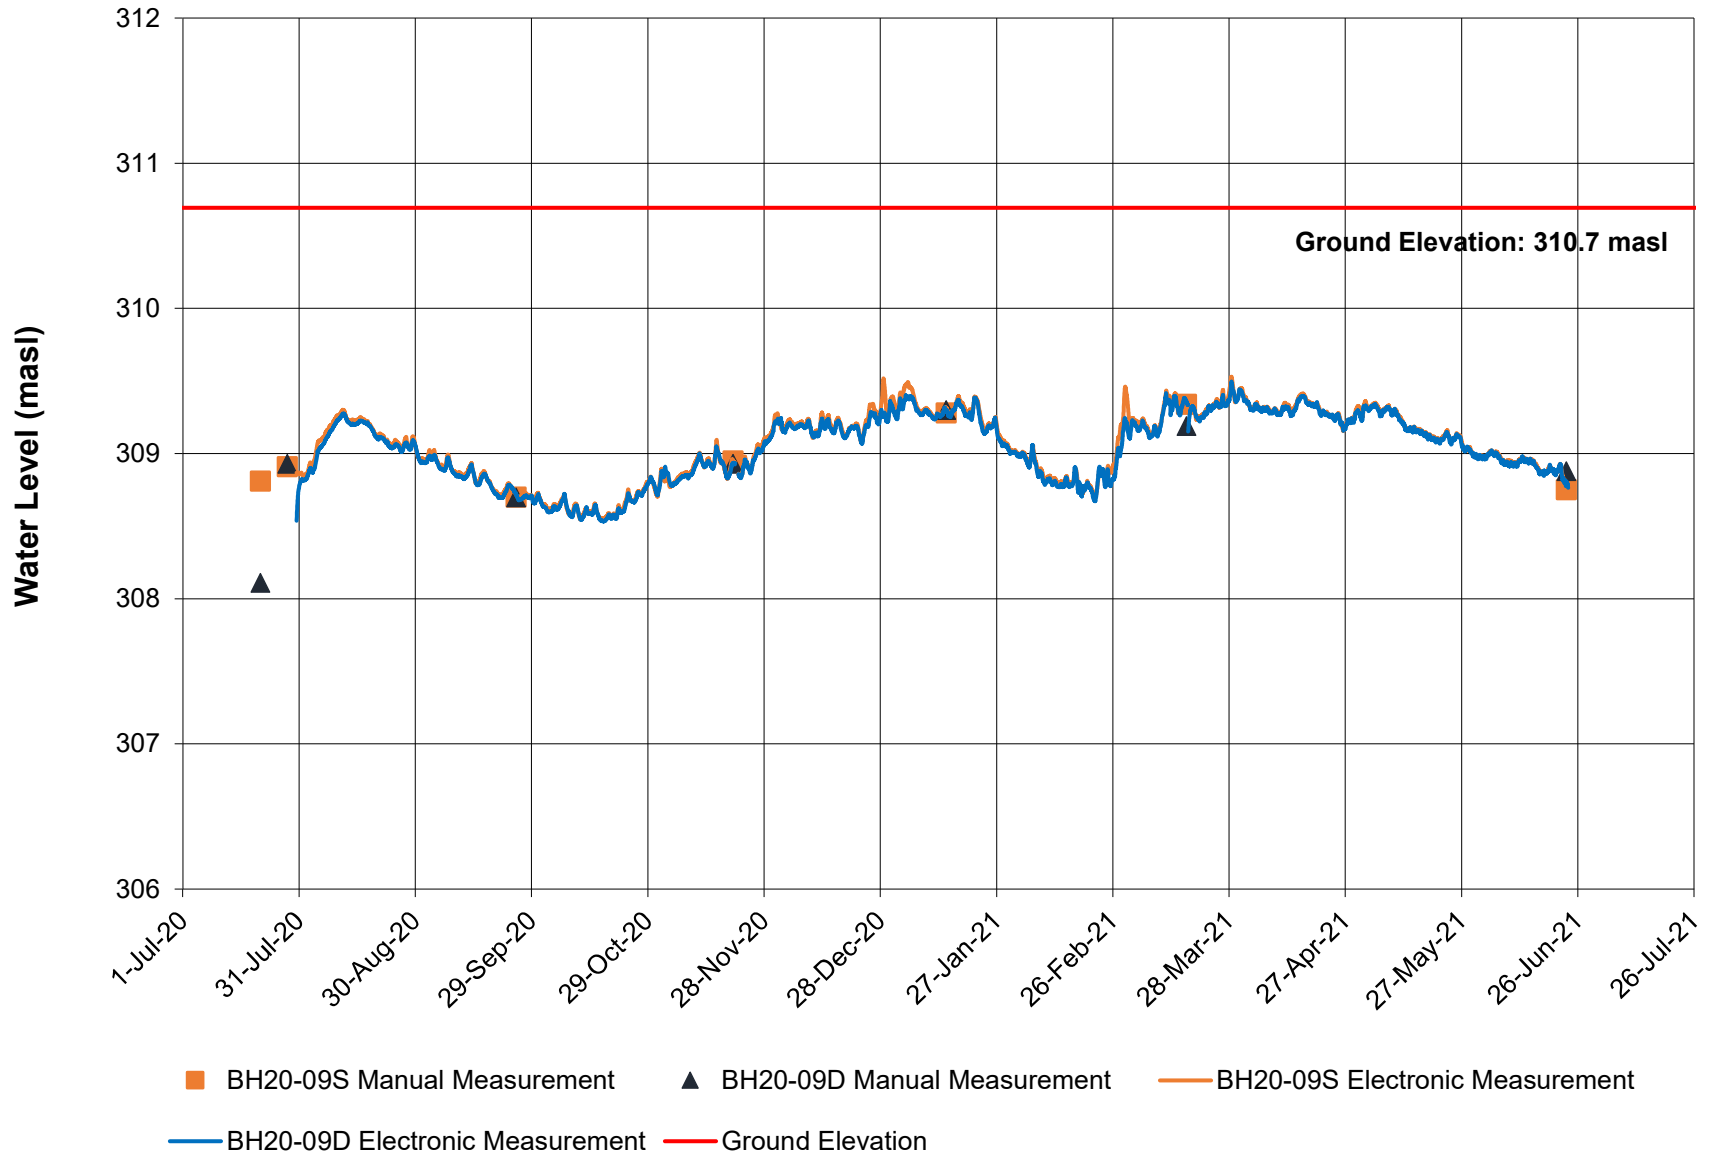
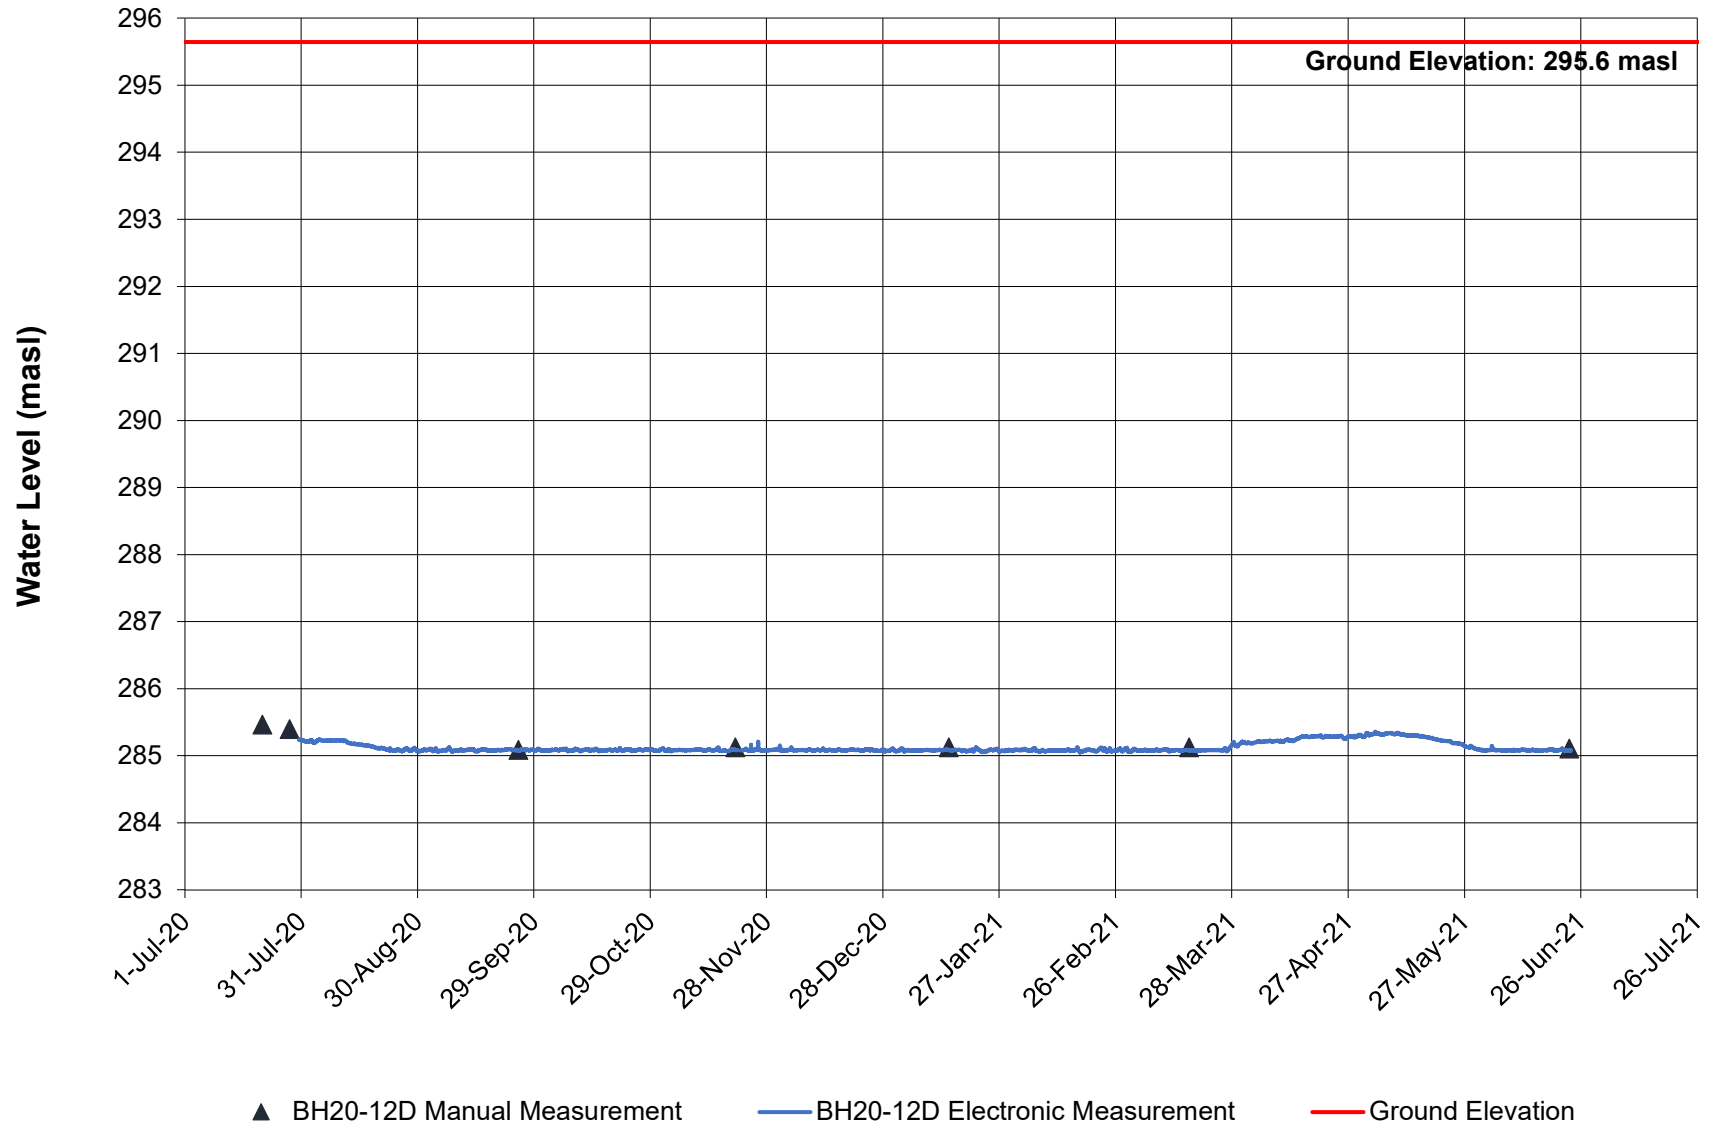
The hydrographs in Appendix A illustrate the seasonal fluctuation in the groundwater levels. Higher groundwater levels were observed during the winter and spring months (December to May), and lower levels were observed during the summer and autumn months (July to November). The range in seasonal fluctuation in each well was from 0.3 m (in Monitoring Well 20-12D) to 2.5 m (in Monitoring Well 20-01) over the course of the monitoring period.
