FLUVIAL GEOMORPHOLOGICAL ASSESSMENT
TESTON ROAD ENVIRONMENTAL ASSESSMENT (BETWEEN 250 METRES
WEST OF PINE VALLEY DRIVE AND KLEINBURG SUMMIT WAY)
VAUGHAN, ONTARIO

Prepared for:
HDR INC.

Prepared by:
MATRIX SOLUTIONS INC.

Version 1.0
March 2022
Mississauga, Ontario

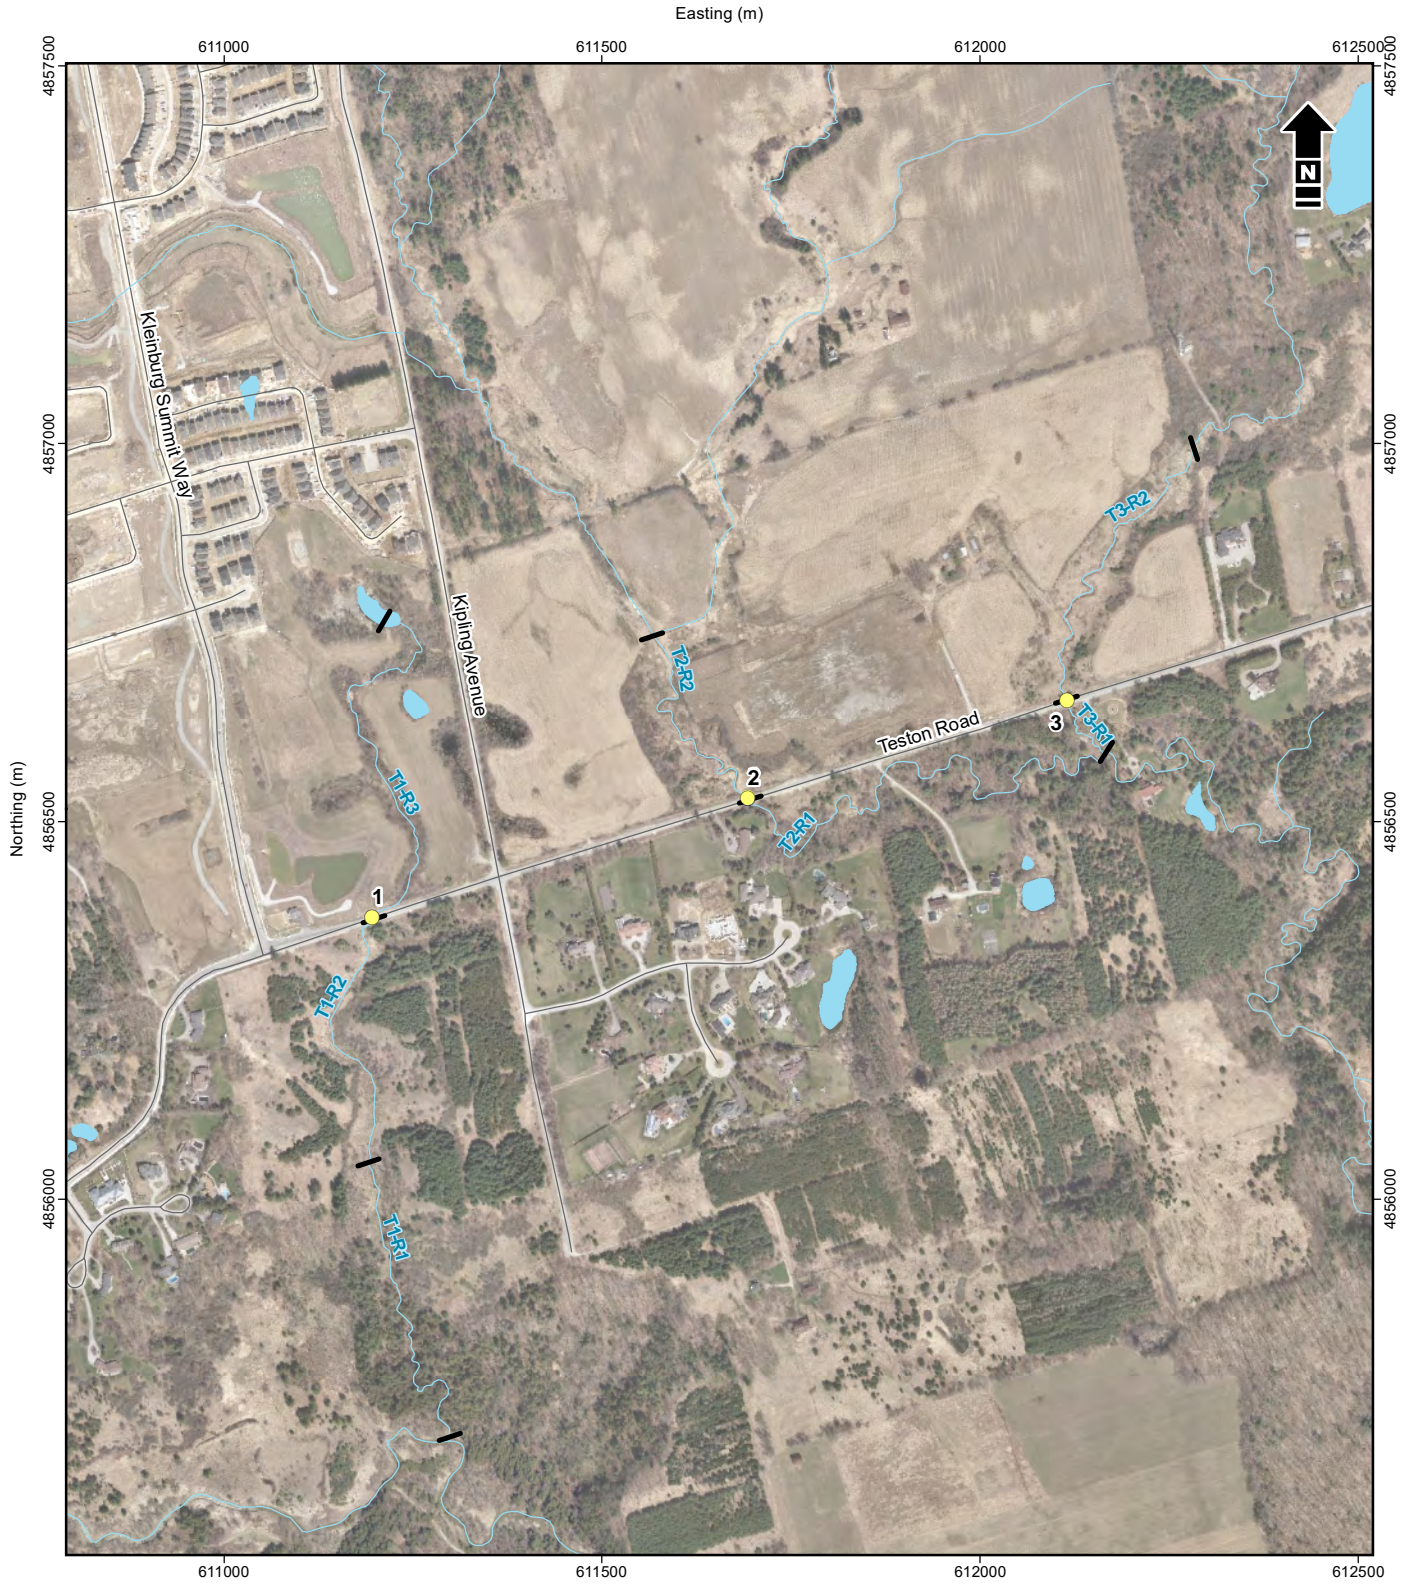
The watercourses in the study area were divided into seven reaches. Refer to Figure 3 for a map of the reaches delineated within the study area.

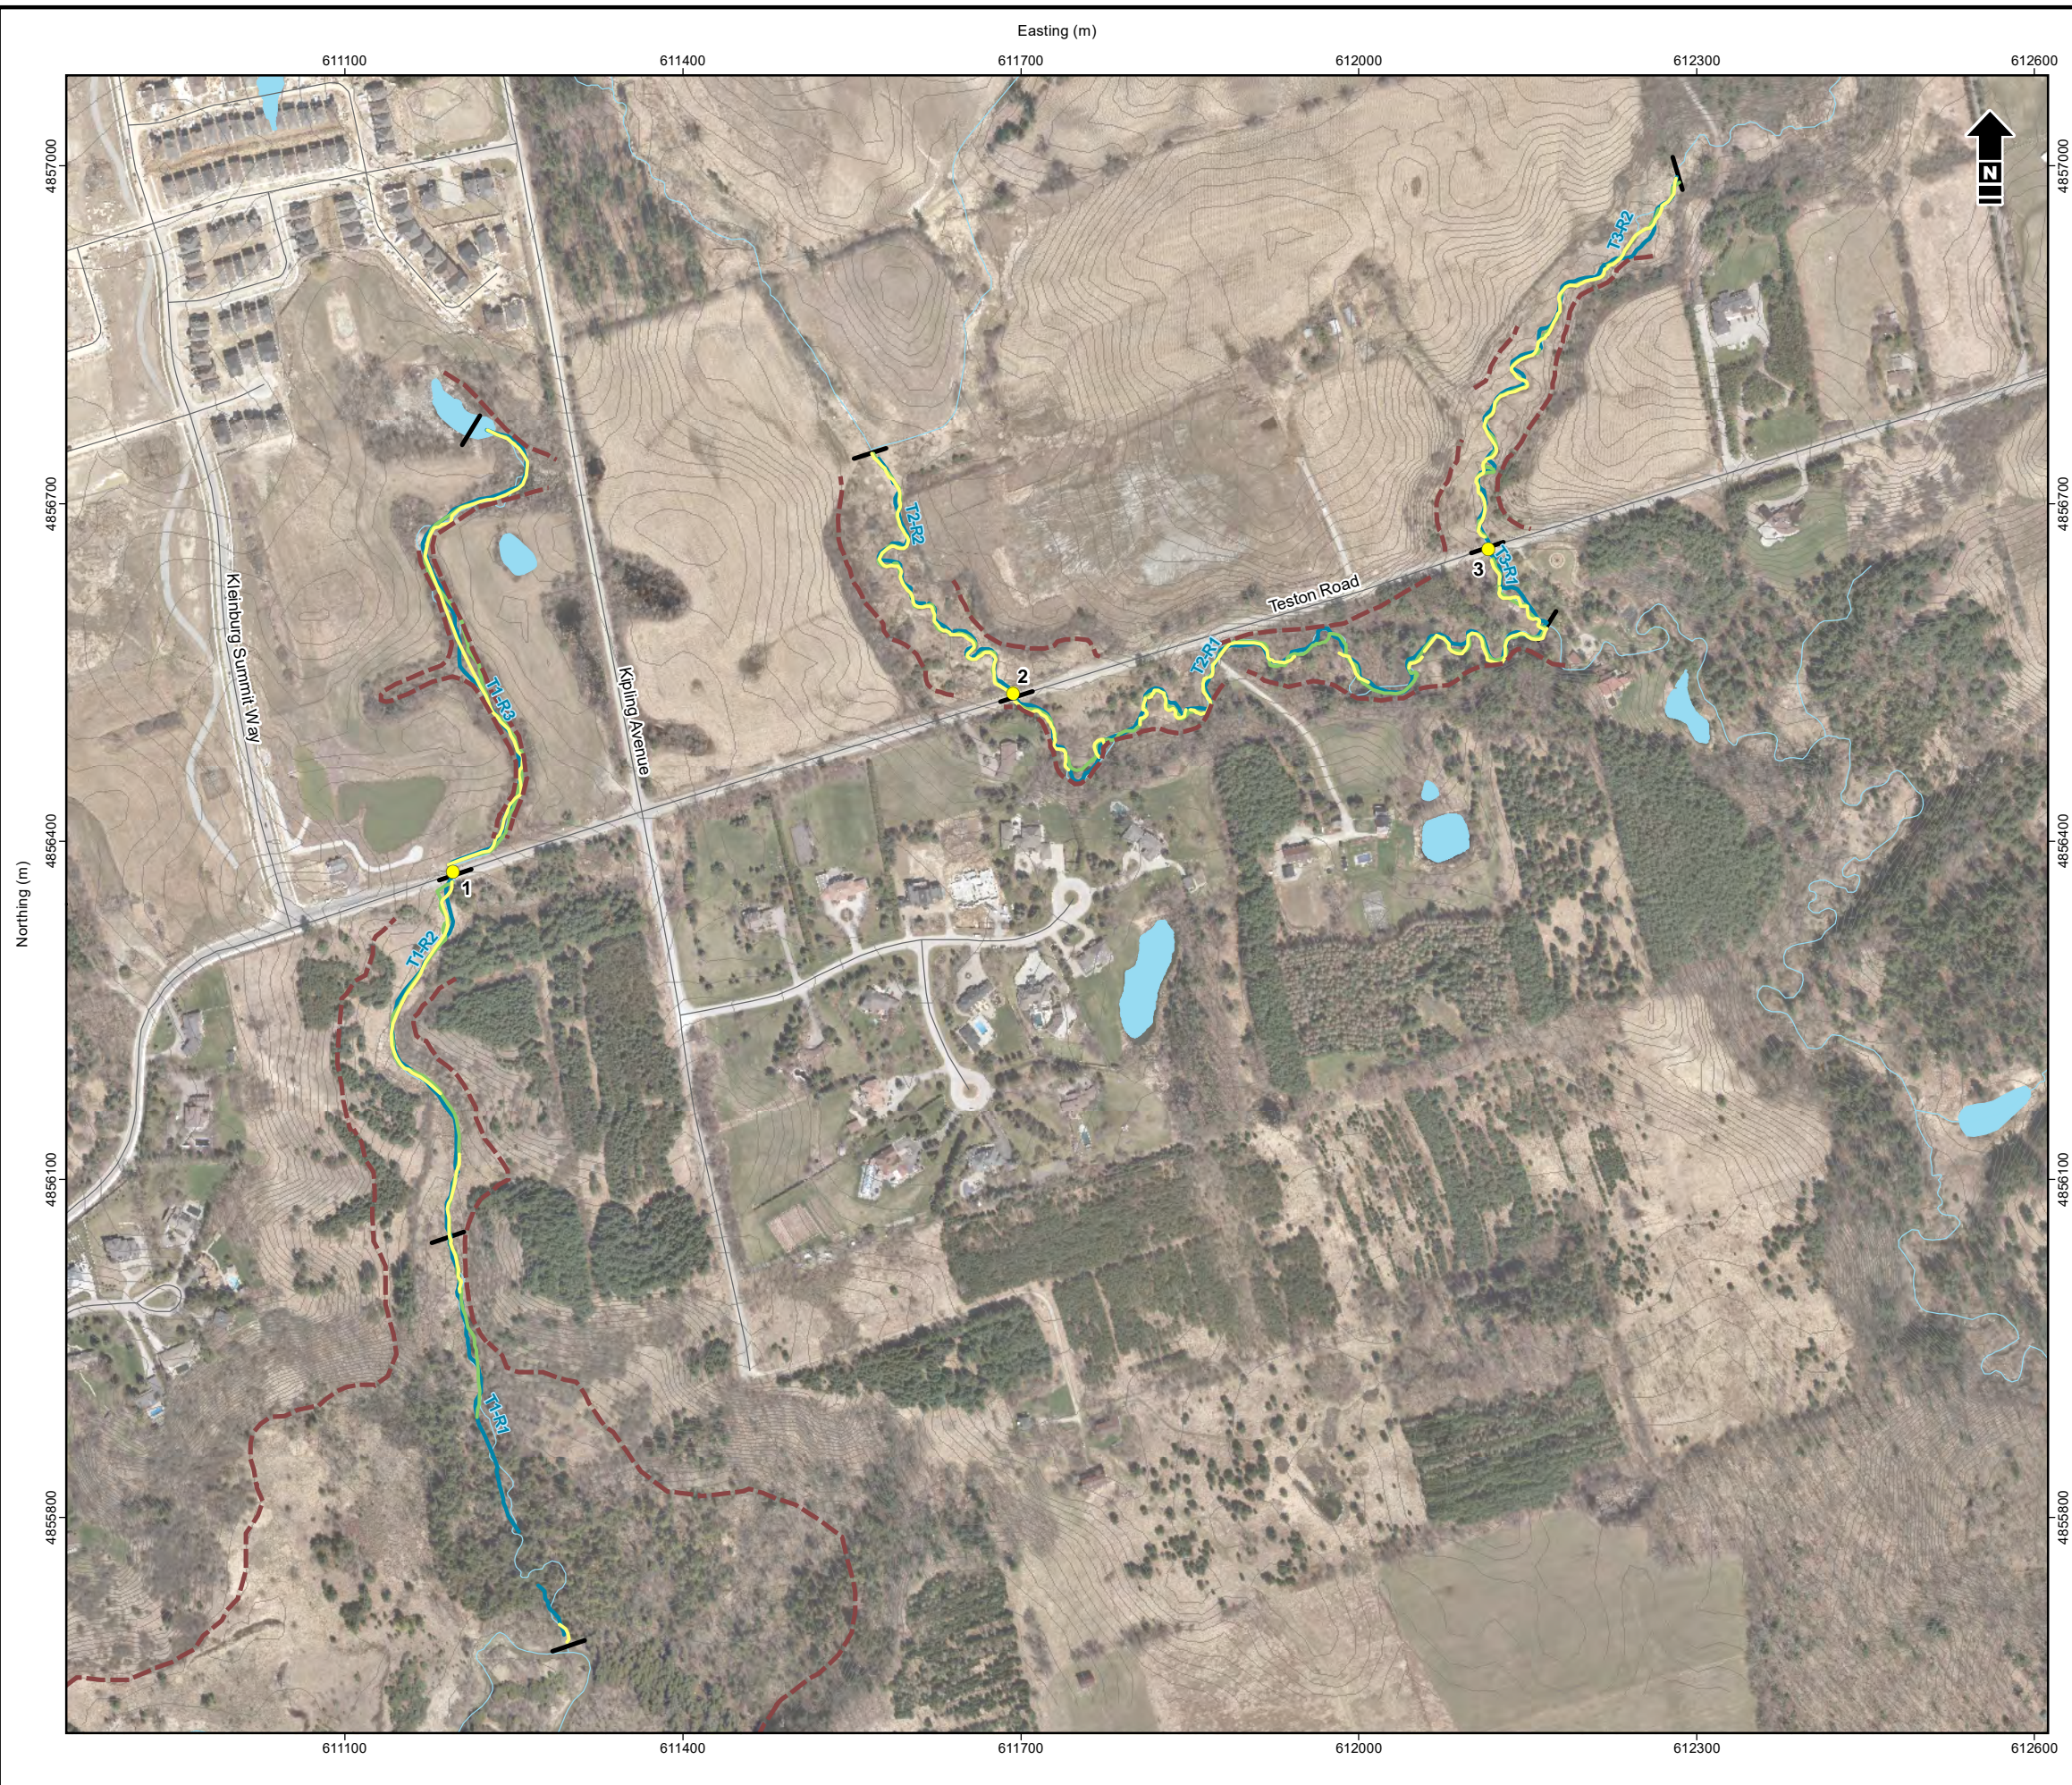
I:\HDC\preparation\31783\FiguresAndTables\GMV\2021\Report\Figure-4-Historical_Channel_Planforms_for_1978_2005_and_2019.mxd - Tabloid_L - 06-Feb-21, 11:37 AM - ImagePrint - TID0005

T1-R2 had been straightened by 1970 and maintained its straight planform in 1978. During this period the tributary lacked riparian vegetation through most of the reach. By 2005, the channel was less distinct and had revegetated with grasses and large portions of the surrounding areas had become forested, particularly south of Teston Road and east of the tributary. The planform was not clearly visible in the 2019 air photograph. The channel does not appear to have changed significantly between the 2005 and 2019 air photographs. Re-naturalization works that were observed in the field on T1-R2 during the site assessments (refer to Section 5) may not have occurred by the time the 2019 orthophotograph was taken.

T1-R3 has occupied the same corridor throughout the period reviewed. The section of the channel immediately upstream of Teston Road has been ditched along the road embankment since the earliest photograph (1970). Upstream of the road right-of-way (RoW), the corridor has had a narrow forested buffer strip through the period reviewed. The farm pond at the upstream extent does not appear to have undergone any notable changes either over the historic period of record. The lands west and north of the tributary corridor were under construction in 2017 and by 2019 had been developed into residential properties. Just north of Teston Road a stormwater (SWM) pond was recently constructed.

T2-R1 has flowed through a vegetated corridor south of Teston Road since the earliest photograph (1970). The density of the tree cover and understorey appears to have increased over time. The channel has an irregularly meandering planform, which does not appear to have changed significantly since 1970. Slight adjustments in the planform were observed where meanders developed a more complex form due to valley confinement. One meander close to the downstream confluence appears to have widened to the south. In this area, the channel is not confined. Since 1970, a residential lane has crossed the tributary and the channel downstream runs along the Teston Road embankment for an estimated distance of 25 m. In 2019, a pond is present, and the planform is less distinct midway between the residential lane and the confluence. This might be due to the influence of beaver dams as discussed in Section 5. Portions of the channel are also obscured by tree cover.

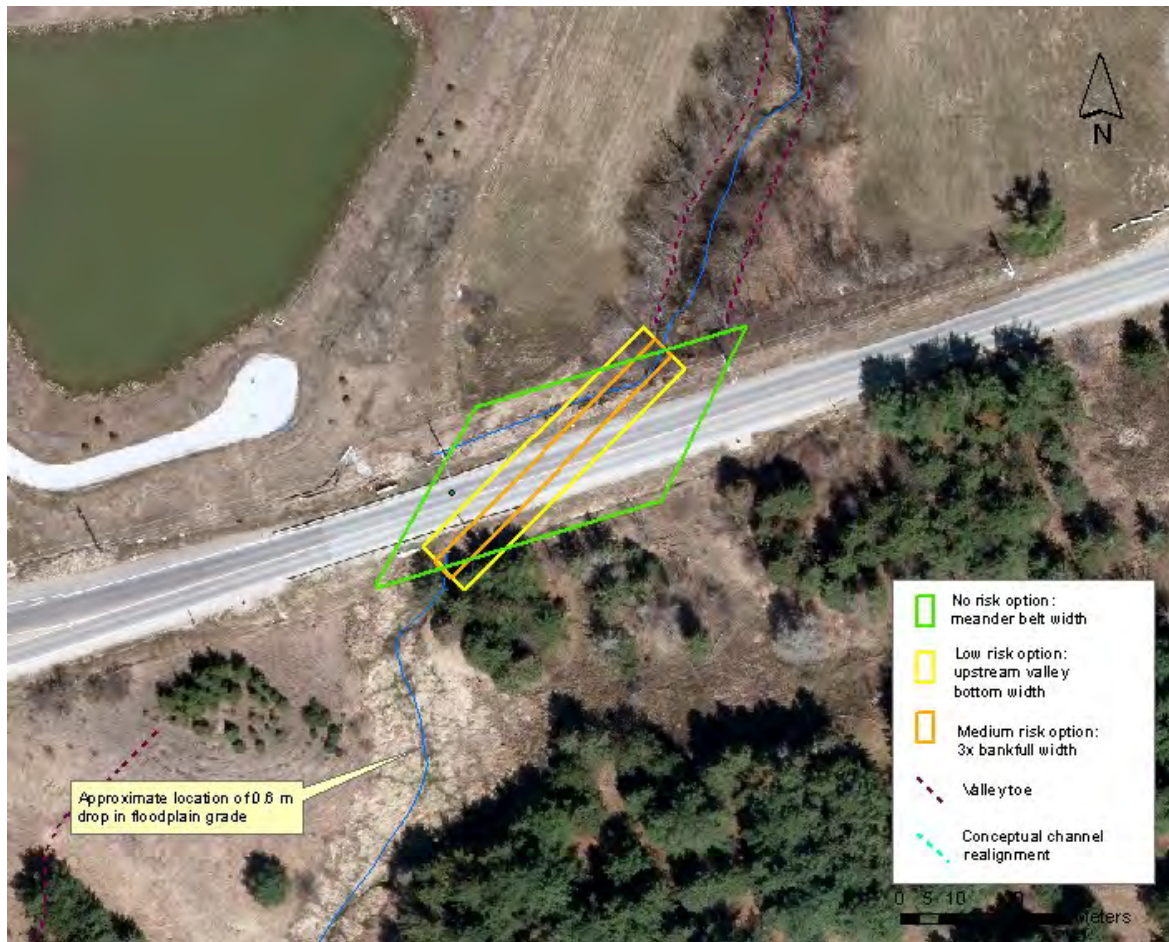
FIGURE 5a Crossing 1 Alignment Option 1: Long Skew

This alignment would connect diagonally from just upstream of the ditched area to the existing culvert outlet. This option would not require channel realignment and would reduce the angle at which the creek enters and exits the crossing. This option has the longest structure length and greatest skew in relation to Teston Road. This option could be applied to all three span options and may impact the SWM outfall culvert to the west.

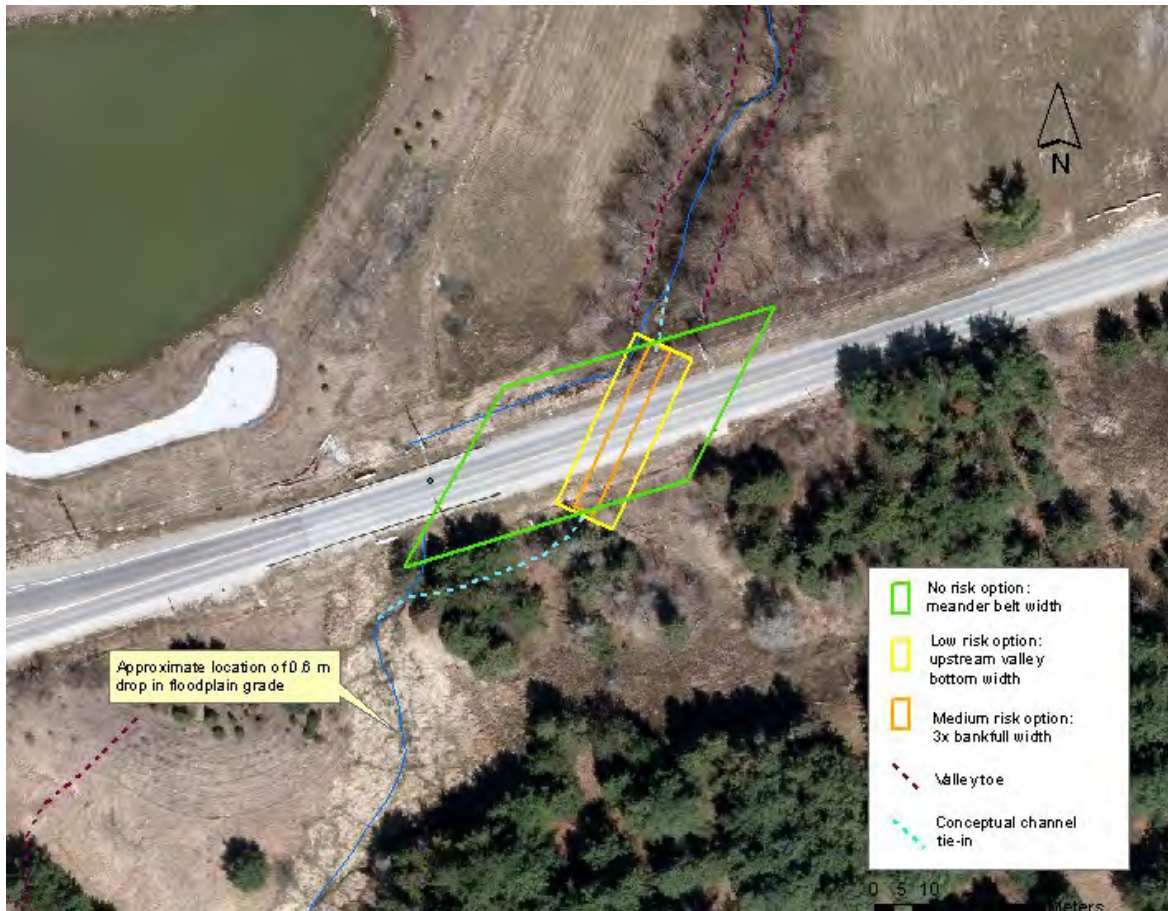
FIGURE 5c Crossing 1 Alignment Option 3: Downstream Realignment

This alignment would shift the culvert inlet east to the align with the creek corridor upstream. This option would require realignment downstream to connect to the existing feature downstream over an estimated distance of 30 m. This option would remove the ditched area north of Teston Road and would replace it with a similar length of channel south of Teston Road which could be an improvement over the existing ditch. The natural form of the channel is generally poorly defined, based on conditions in adjacent reaches, and as such any it may be advisable to consider replicating a broad wetland area with a small low flow channel through the realignment. Consultation with TRCA is advised to develop an appropriate realignment design, as the TRCA has completed re-naturalization works immediately downstream of Teston Road in Reach T1-R2. The realignment may require some tree removal on the south side of Teston Road; however, there are also existing low-lying wet areas around trees that could be targeted in design to ensure maintenance with shallow groundwater connections. Because the crossing would be located east of the existing structure, the new structure could be built while the existing crossing remains open without the need for bypass pumping.

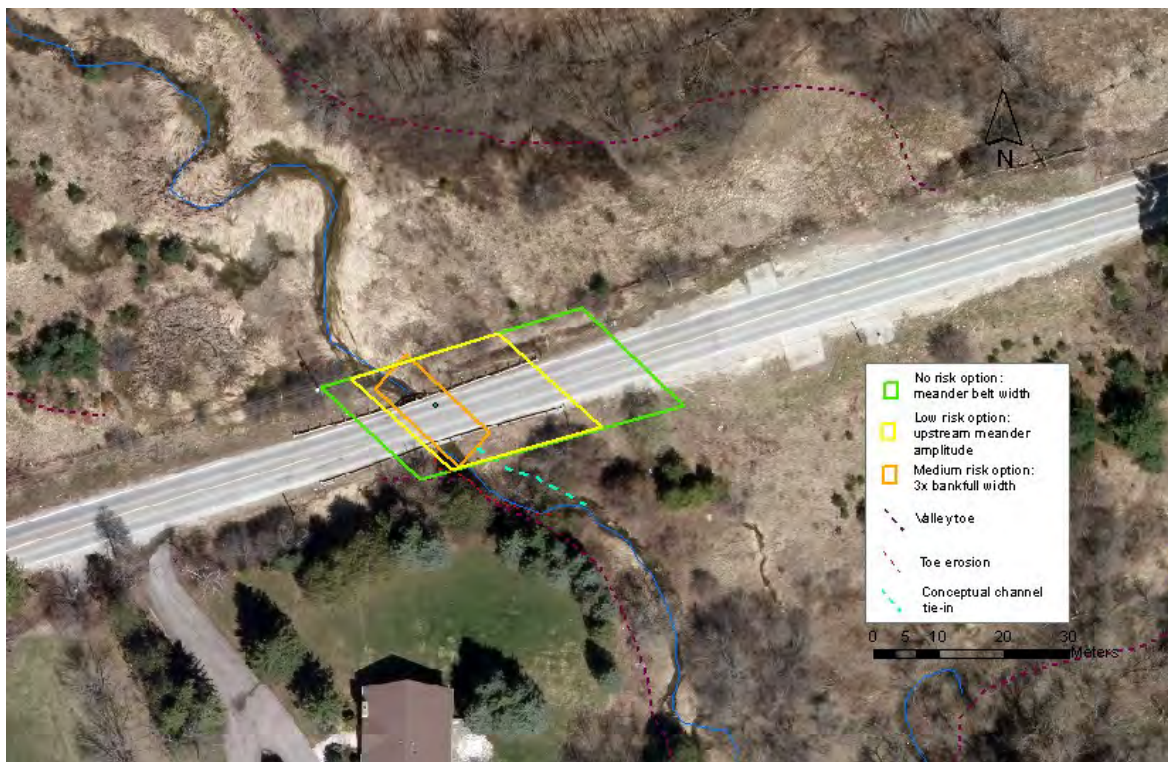
FIGURE 6 Crossing 2 Options

The option that would pose no erosion risk would have a span of 36 m, which is based on the final meander belt width upstream of the crossing. A span of this width would encompass the entire corridor in which the channel may meander over the long term. To accommodate the valley form, the structure would widen to the east and channel tie in works would be required. It is understood that spanning the meander belt is not generally feasible in terms of cost and constraints (such as accommodating such a structure within the road profile) but is presented here to provide insight into geomorphic risk. This option could widen to the east of the existing culvert centreline.

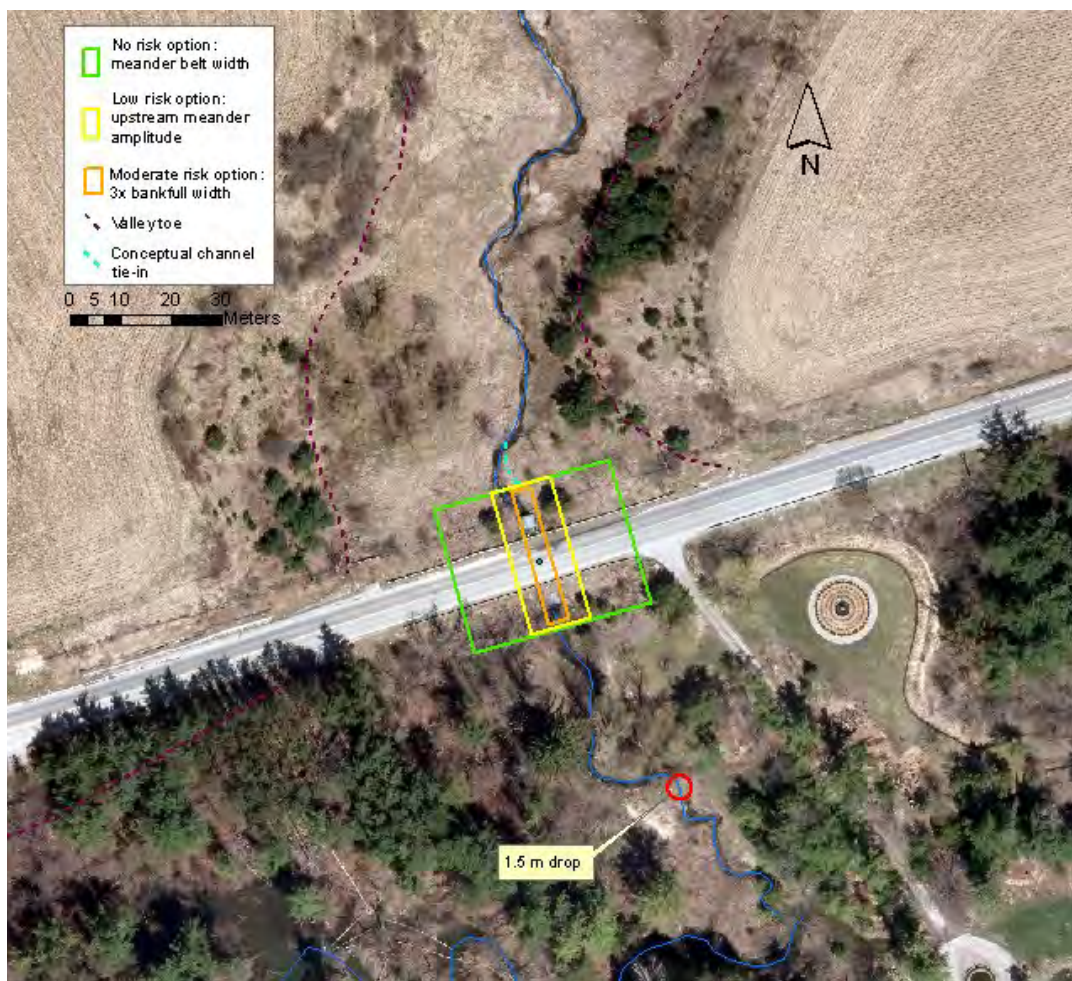
FIGURE 7 Crossing 3 Options

The option that would pose no erosion risk would have a span of 36 m, which is based on the final meander belt width upstream and downstream of the crossing. A span of this width would encompass the entire corridor in which the channel may meander over the long term. It is understood that spanning the meander belt is not generally feasible in terms of cost and constraints (such as accommodating such a structure within the road profile) but is presented here to provide insight into geomorphic risk.

For any option, post-construction monitoring of the downstream drop in elevation is recommended. All options presented would be aligned with the existing culvert centerline.

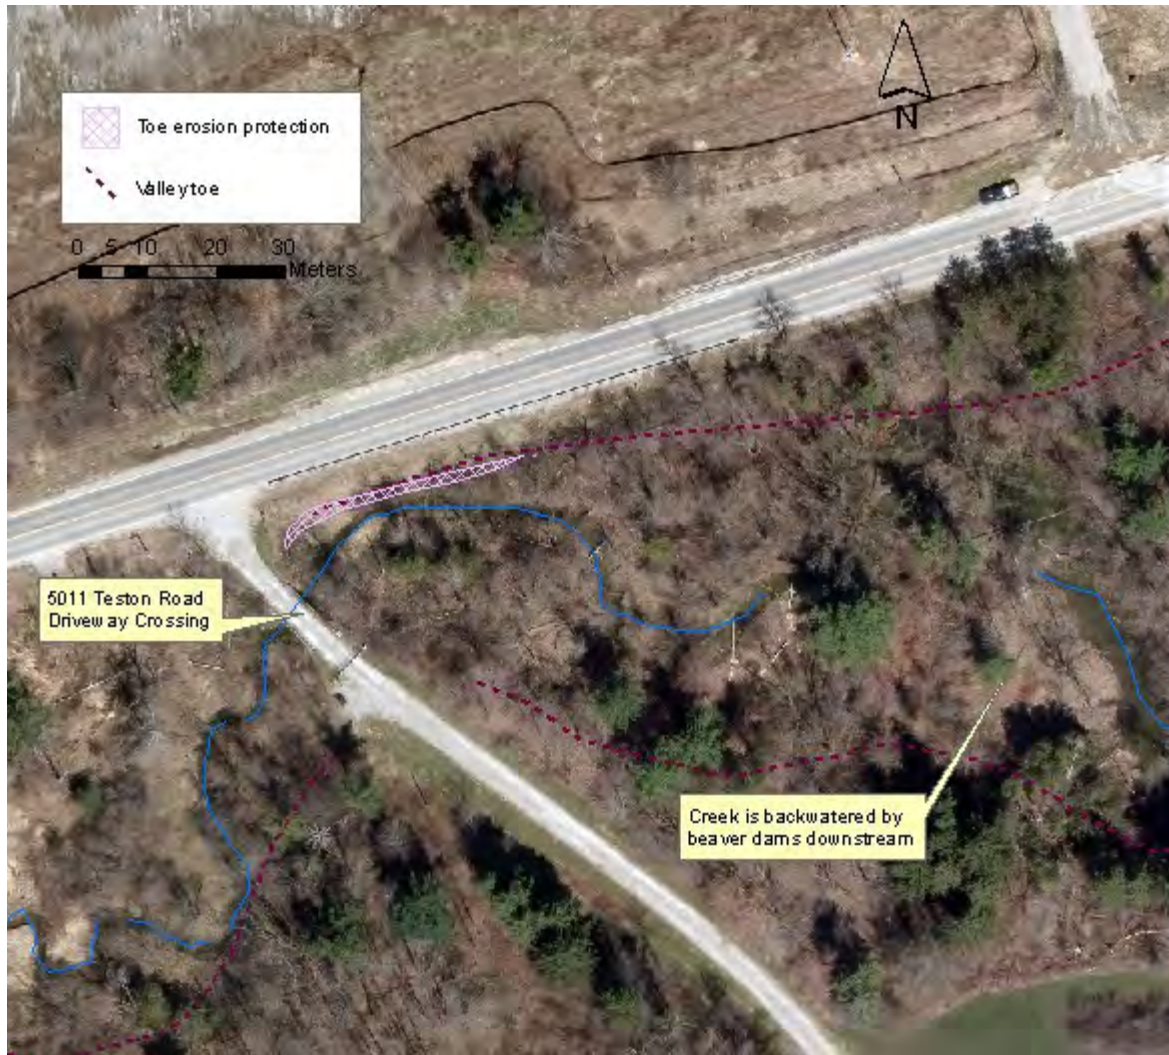
FIGURE 8a Road Embankment Option 1: Road Widening to the North, Proposed Toe Erosion

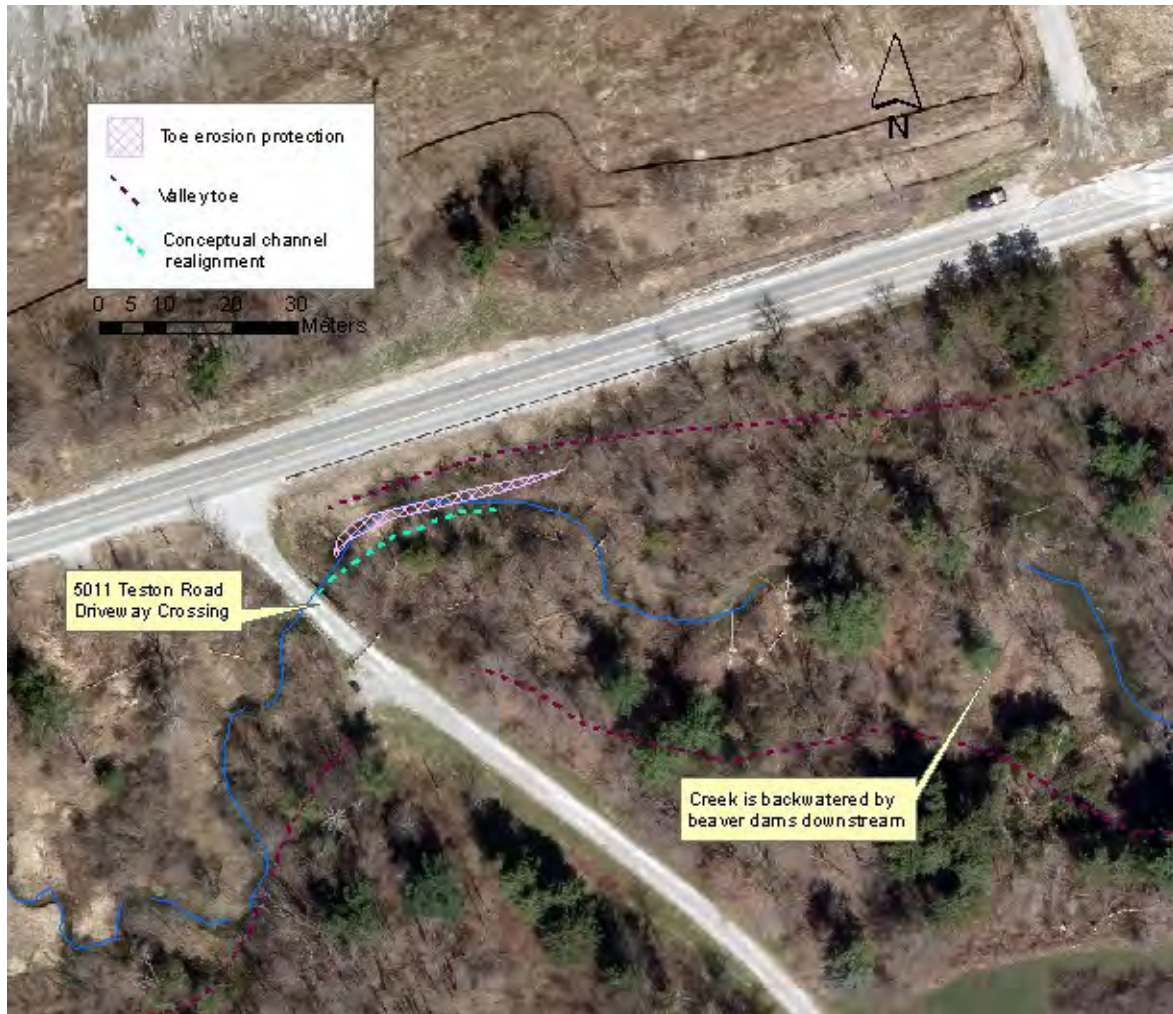
- **Option 2 widening road from centreline of existing Teston Road alignment:** should the road be widened to the north and south, a minor channel realignment would be required, along with ~25+/-5 m of toe protection along the embankment. This option is the less preferred because it would require more alteration to the existing channel than Option 1.

FIGURE 8b Road Embankment Option 2: Road Widening Along Existing Centreline, Proposed Toe Erosion Protection, and Channel Realignment

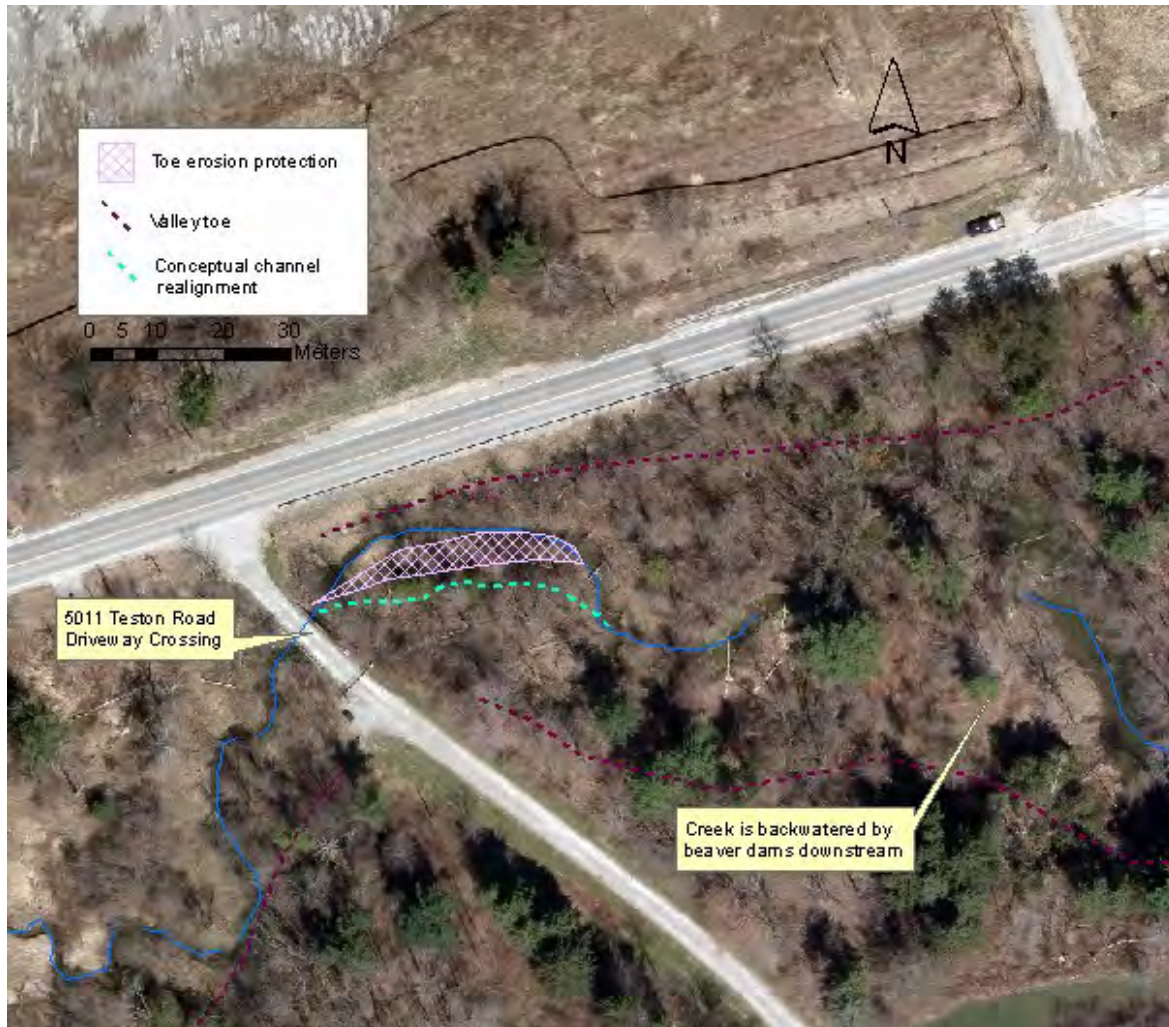
- **Option 3 widen road to south:** this option would require more substantial channel realignment and toe erosion protection works and would likely require work on the private crossing structure south of Teston Road. This option is the least preferred because it would require considerable alteration to the existing channel and valley corridor.

FIGURE 8c Road Embankment Option 3: Road Widening to the South, Proposed Toe Erosion Protection, and Channel Realignment

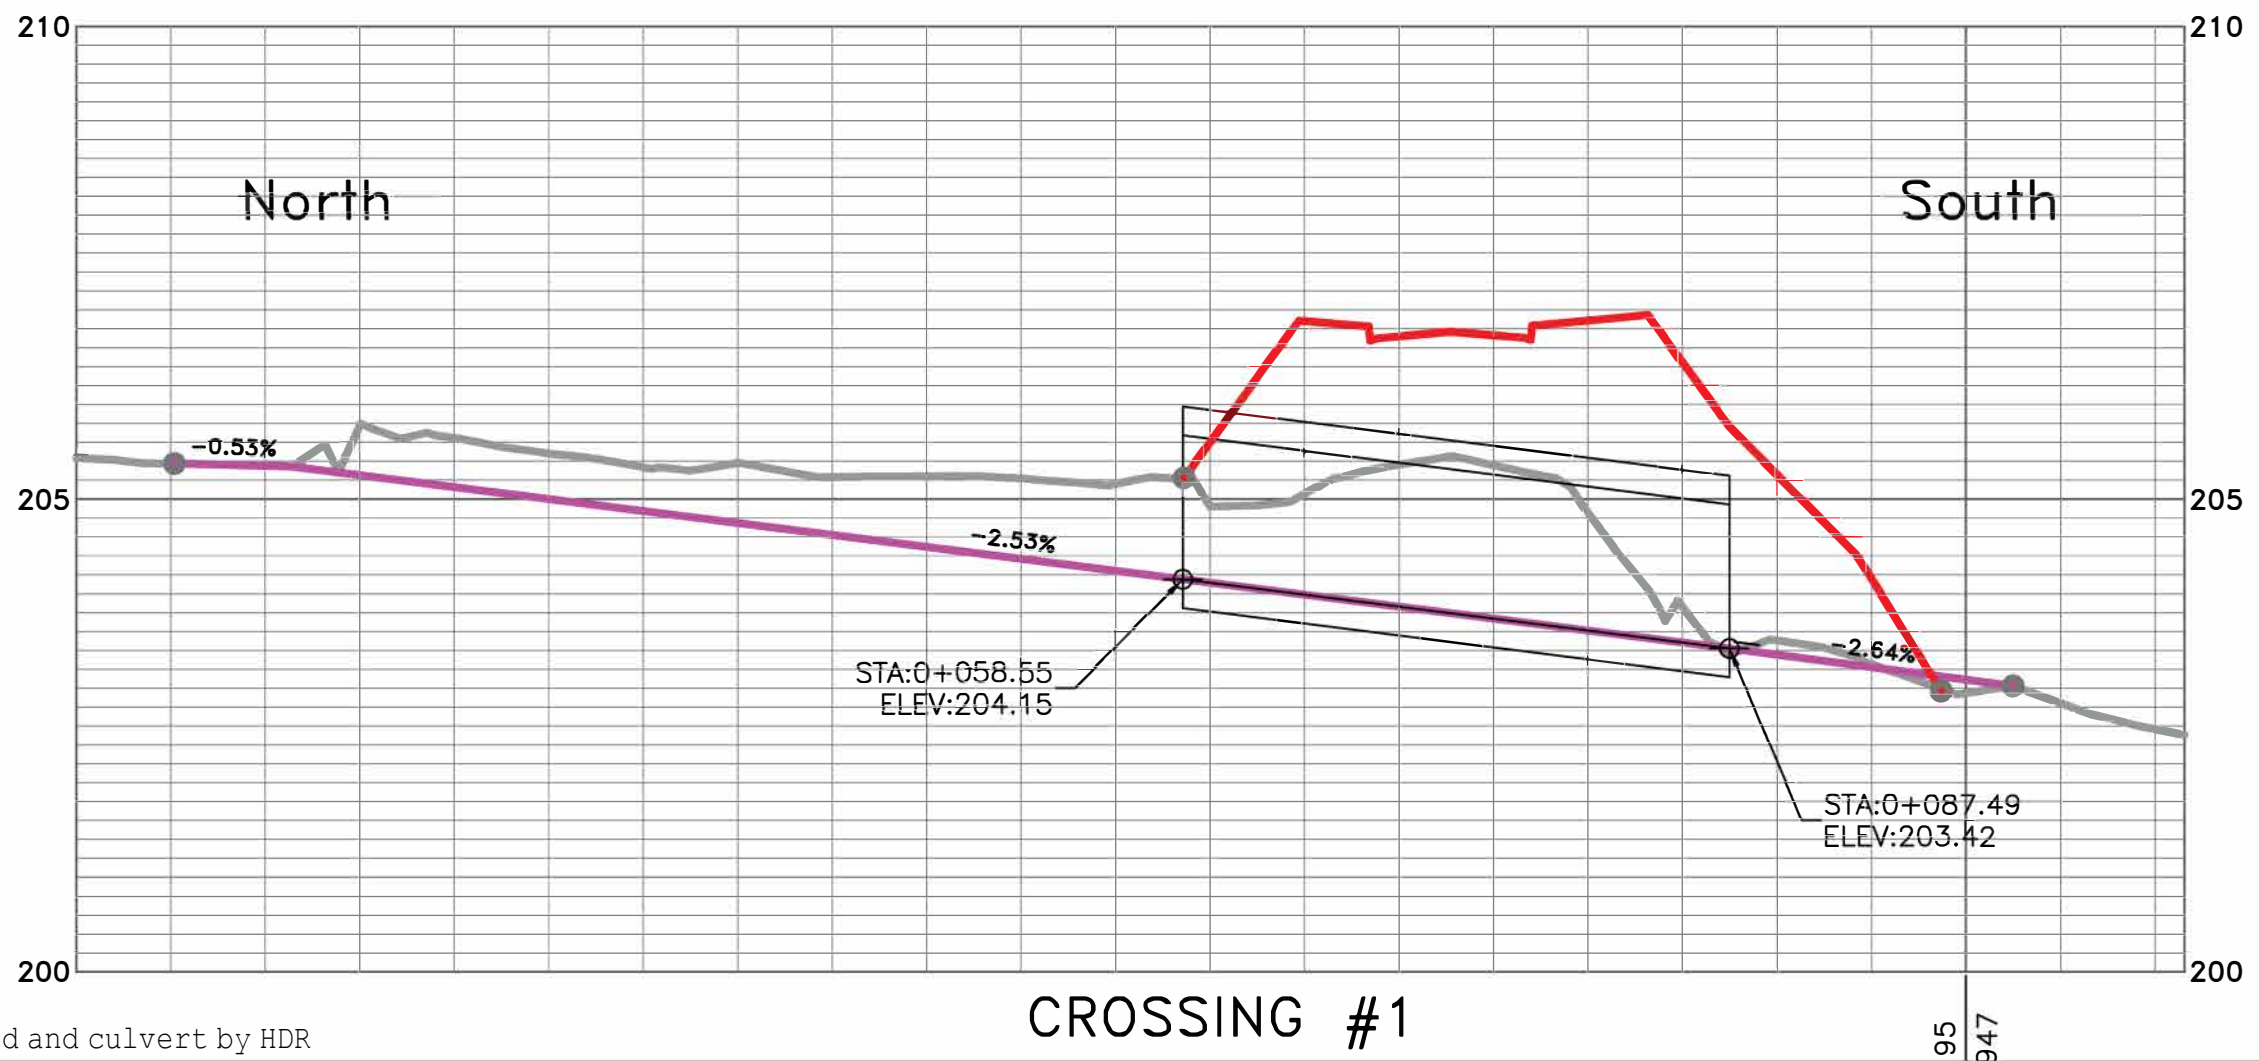
Figure 9a: Crossing #1
Plan and Profile

Conceptual corridor limits and a conceptual channel centerline for the upstream realignment are presented in Figure 9a. The realignment introduces a sinuous planform which extends beyond the proposed right-of-way. Table 9 provides the channel length, slope, and sinuosity for the conceptual planform. The tie-in elevations and planform and corridor parameters should be revisited and confirmed in later design stages.

The preliminary slope through the crossing and upstream channel realignment is 2.53%. The slope of the channel tie-in downstream of the crossing is 2.64%. These values represent straight-line channel distances and do not incorporate additional stream length from channel sinuosity. The slopes have been defined based on cover requirements at the roadway and may be refined at detailed design.

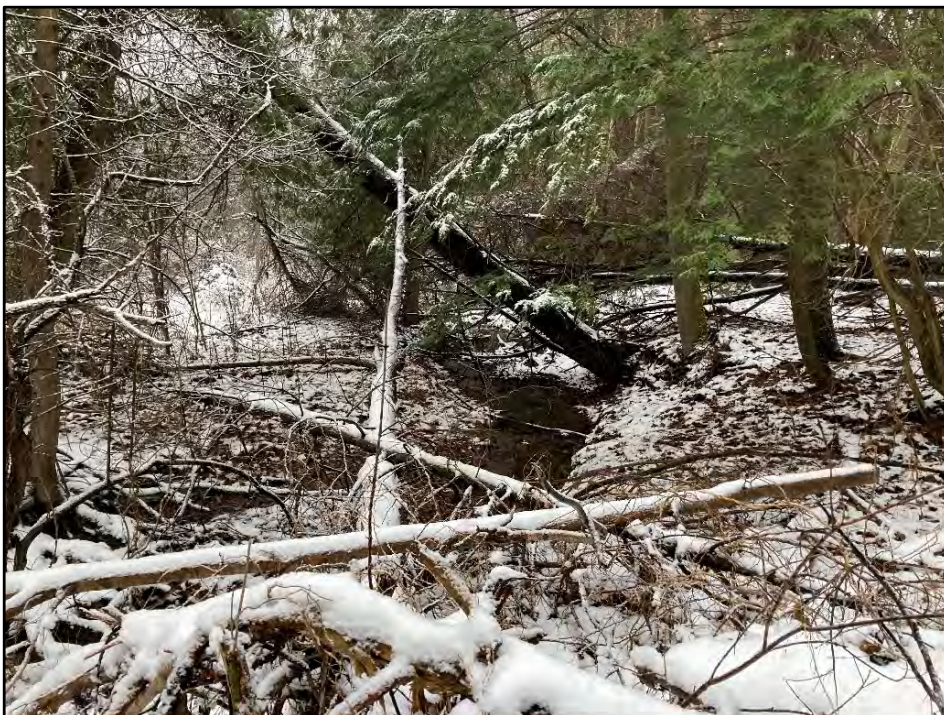
4. T1-R1 looking upstream mid-reach. Channel is slightly entrenched and woody debris is abundant.

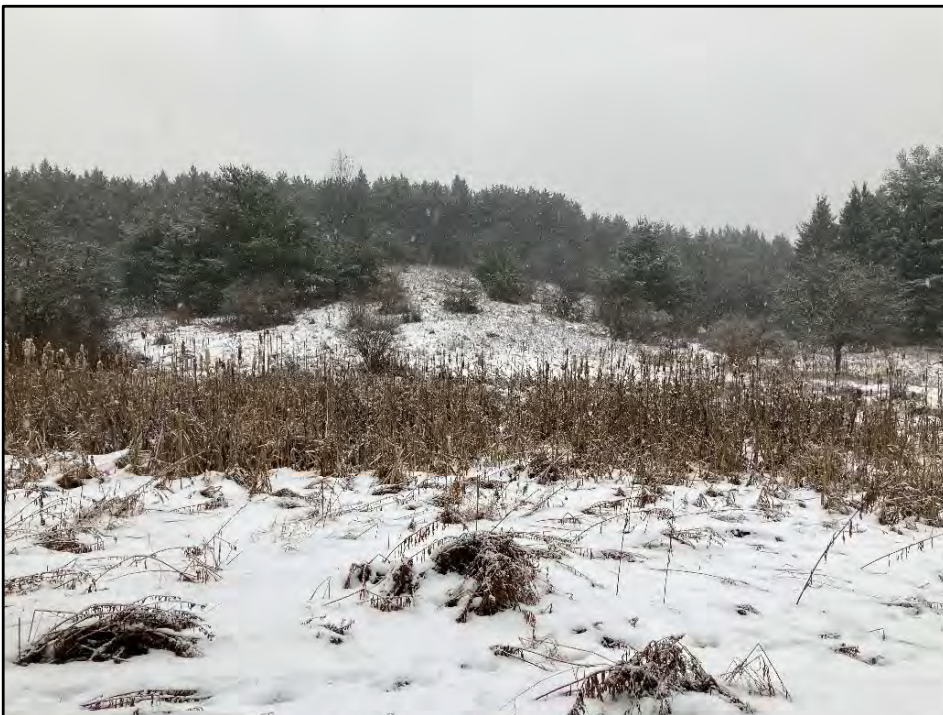
6. Reach T1-R2 looking across the feature to the west in the downstream portion of the reach. In this area the feature is a marsh with no defined channel.

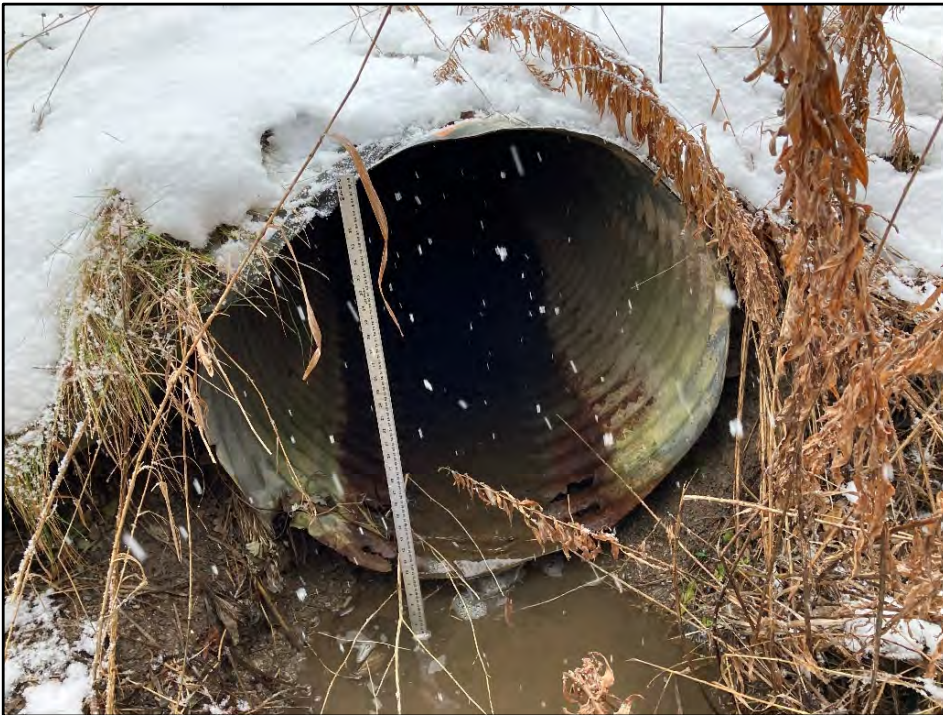
The channel is considerably narrower upstream of the crossing (bankfull width = 1.0 m) than downstream (bankfull width = 3.6 m) due in part to local overwidening caused by scour associated with the crossing. Erosion on the right bank begins approximately 7 m downstream of the outlet and extends to approximately 25 m from the outlet along a valley wall contact. There is a residential property located west of this valley slope. The skew of the existing culvert alignment directs flow toward a valley contact at the outlet. The valley slope is approximately 2 m high with a slope of 2:1, and the toe erosion is approximately 0.5 m high, with some shallow undercutting. No evidence of instability was noted at the culvert inlet. The creek is centered in the culvert at the inlet and runs along the east abutment at the outlet. The structure is in poor condition with leaning guardrails and deteriorated concrete. Cracks were noted on the asphalt pavement above the culvert.

9. Crossing 1 outlet.

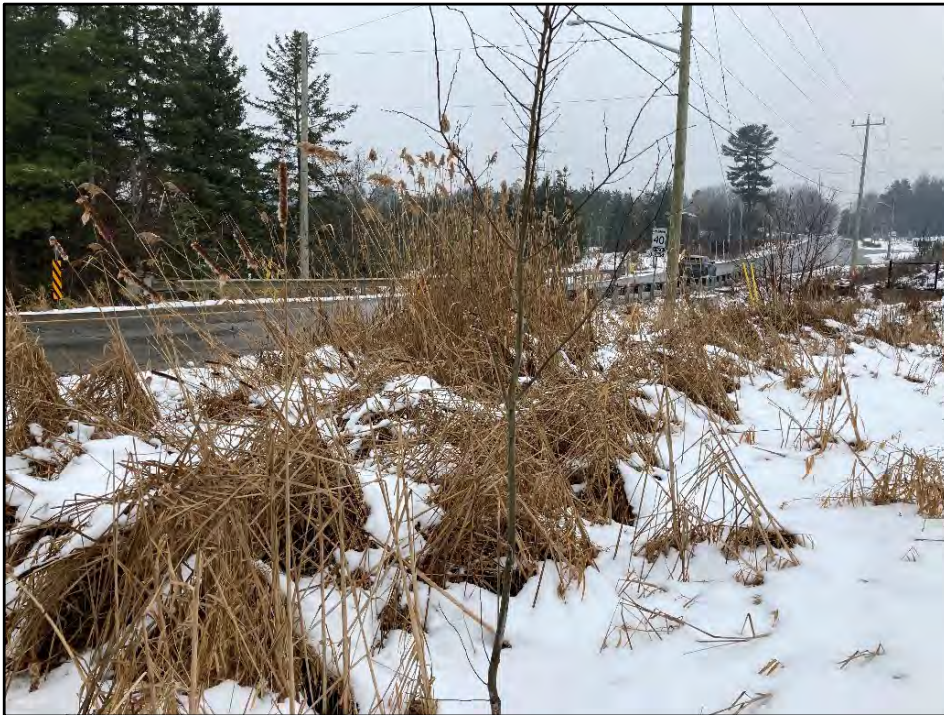
The creek is ditched upstream and turns at a 90-degree angle to enter the culvert. It is noted that the channel is generally not well defined outside of the Teston Road RoW. The channel dimensions listed in Table 4 represent modified conditions within the RoW and may not be indicative of the natural condition. The existing culvert is approximately perpendicular to Teston Road. The crossing contained 4 cm of muddy substrate. At the outlet, the culvert is perched by 20 cm above grade, and, at the time of the site visit, the drop in water level was 8 cm. The culvert outlets into a treed area. Approximately 20 m downstream, the creek disperses into opportunistic flow (no defined channel) as it traverses a recently re-naturalized wetland area. Within this area, approximately 35 m downstream of the culvert outlet, a drop in grade was noted. It has been confirmed that this drop was created as part of the re-naturalization works, the design of which was reviewed by TRCA water resource engineers to ensure no negative impacts on the roadway or nearby infrastructure (TRCA 2020, HDR correspondence 2020).

11. Crossing 1: Looking west toward culvert inlet. Inlet was obscured by reeds and snow.

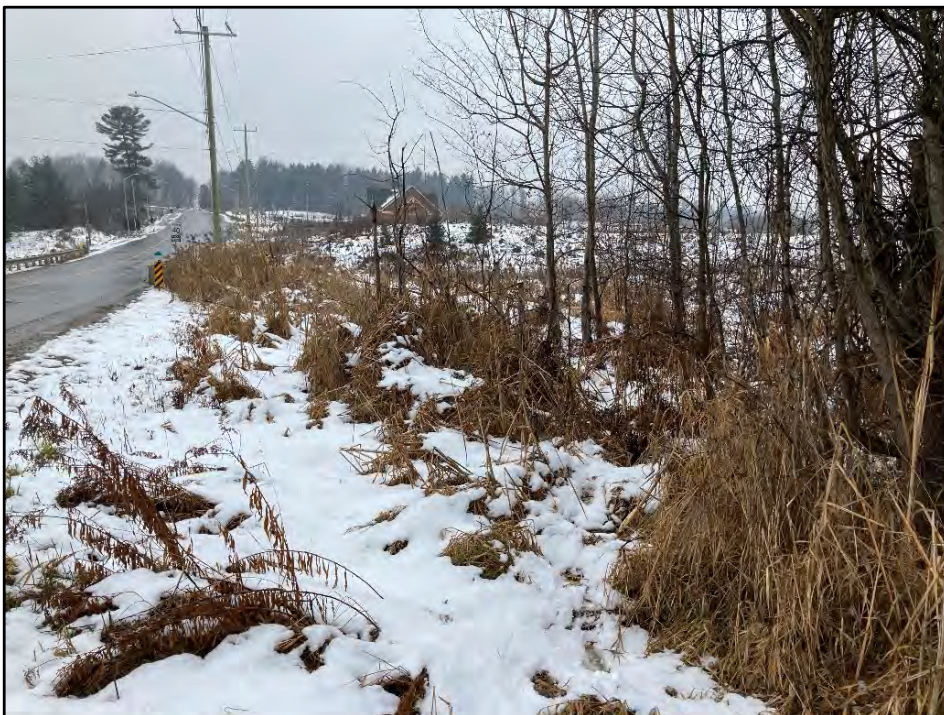
12. Reach T1-R3 looking west along ditched portion of the reach, north of Teston Road.
