FLUVIAL GEOMORPHOLOGICAL ASSESSMENT
TESTON ROAD ENVIRONMENTAL ASSESSMENT (BETWEEN 250 METRES
WEST OF PINE VALLEY DRIVE AND KLEINBURG SUMMIT WAY)
VAUGHAN, ONTARIO

Prepared for:
HDR INC.

Prepared by:
MATRIX SOLUTIONS INC.

Version 1.0
March 2022
Mississauga, Ontario

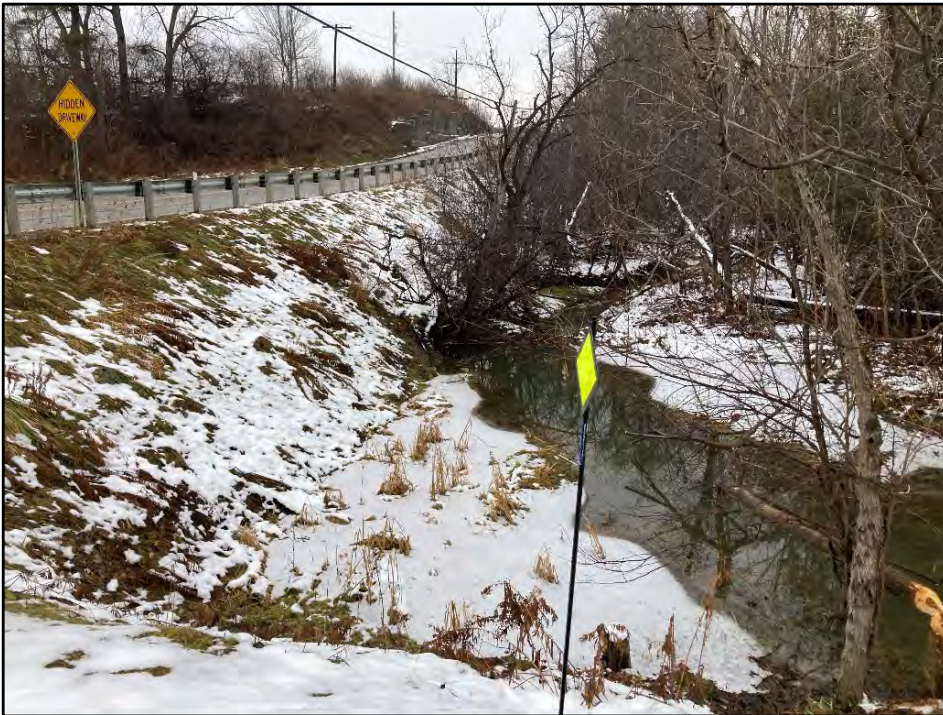
23. T2-R1 looking east (downstream) from 5011 Teston Road crossing. Channel runs along the toe of the embankment slope.

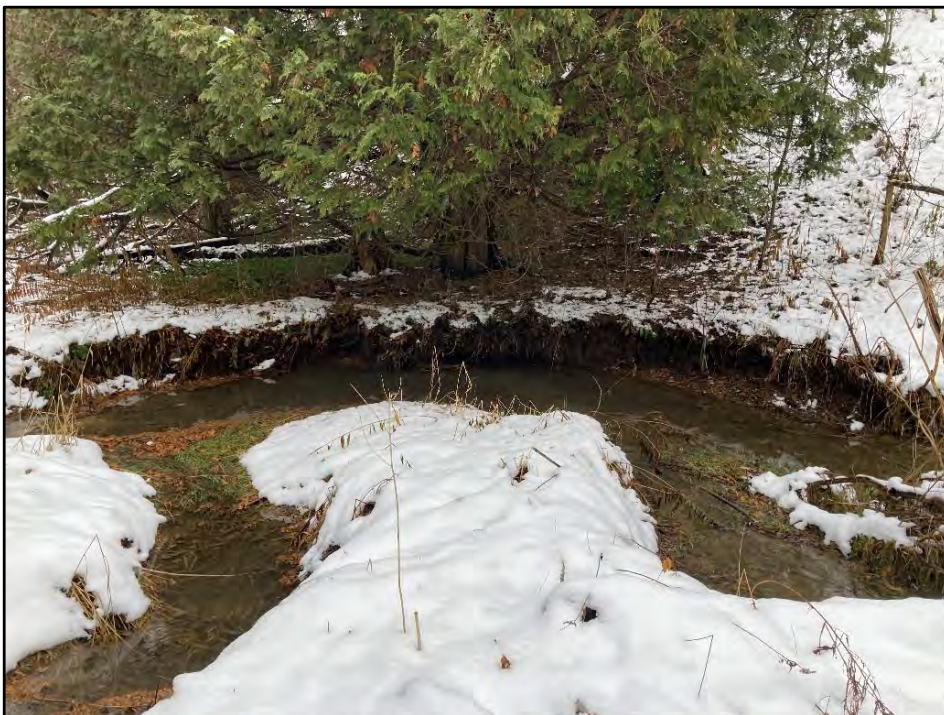
26. Reach T2-R1 meandering channel and bank erosion at a valley contact

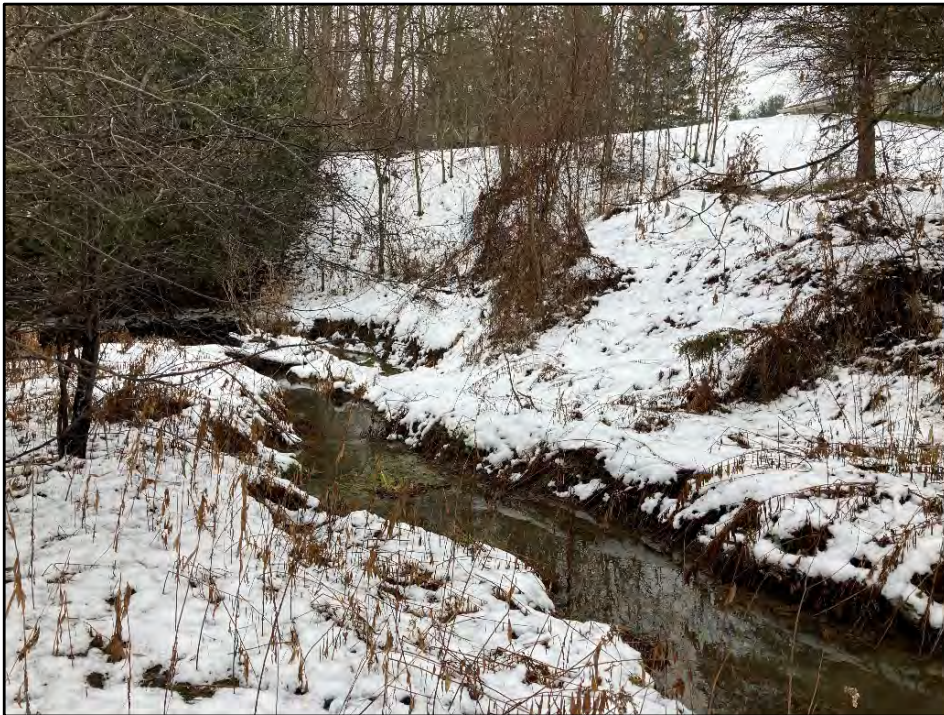
27. Reach T2-R1 looking downstream along valley contact south of Teston Road crossing. Channel runs along the valley toe.

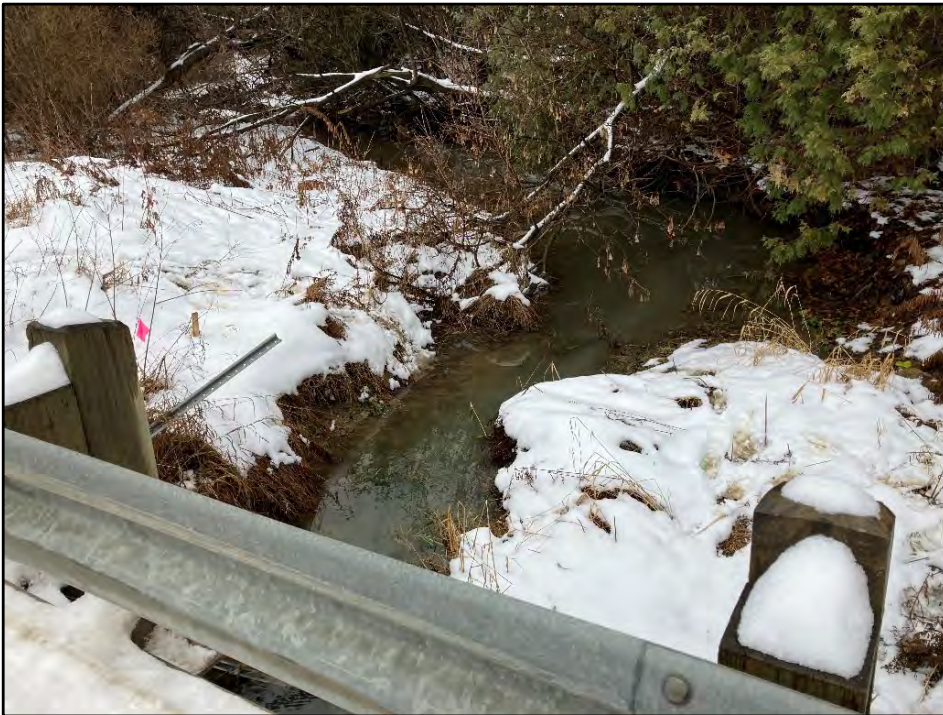
The channel is considerably narrower upstream of the crossing (bankfull width = 1.0 m) than downstream (bankfull width = 3.6 m) due in part to local overwidening caused by scour associated with the crossing. Erosion on the right bank begins approximately 7 m downstream of the outlet and extends to approximately 25 m from the outlet along a valley wall contact. There is a residential property located west of this valley slope. The skew of the existing culvert alignment directs flow toward a valley contact at the outlet. The valley slope is approximately 2 m high with a slope of 2:1, and the toe erosion is approximately 0.5 m high, with some shallow undercutting. No evidence of instability was noted at the culvert inlet. The creek is centered in the culvert at the inlet and runs along the east abutment at the outlet. The structure is in poor condition with leaning guardrails and deteriorated concrete. Cracks were noted on the asphalt pavement above the culvert.

29. T2-R1 looking downstream from Teston Road crossing (Crossing 2). The channel is overwidened several meters downstream of the culvert outlet where it reaches a valley contact.

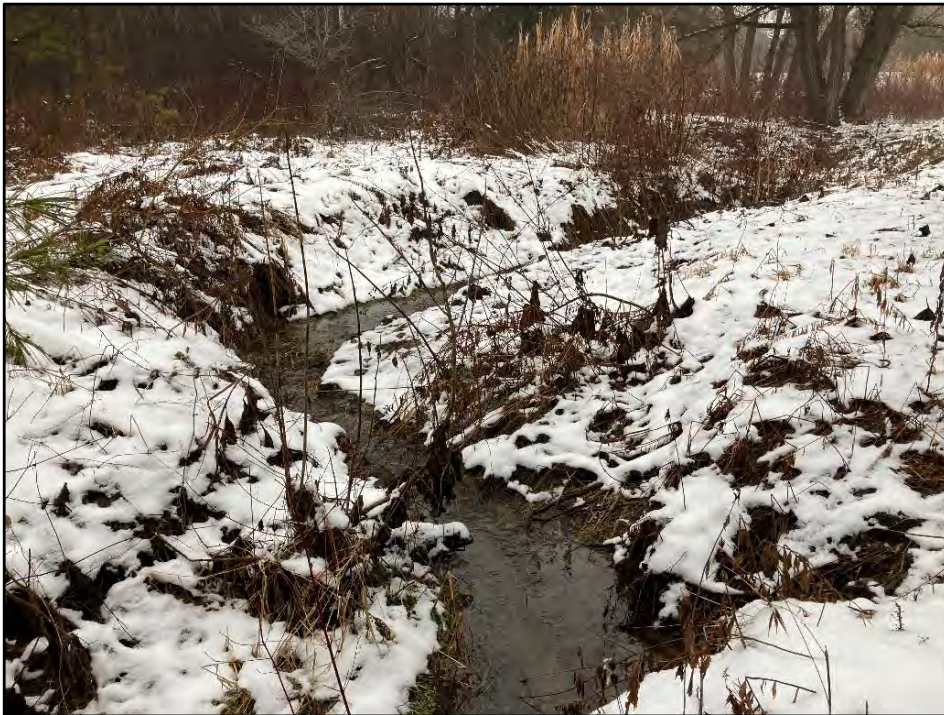
33. Reach T3-R1: Entrenched portion of reach looking downstream toward confluence.

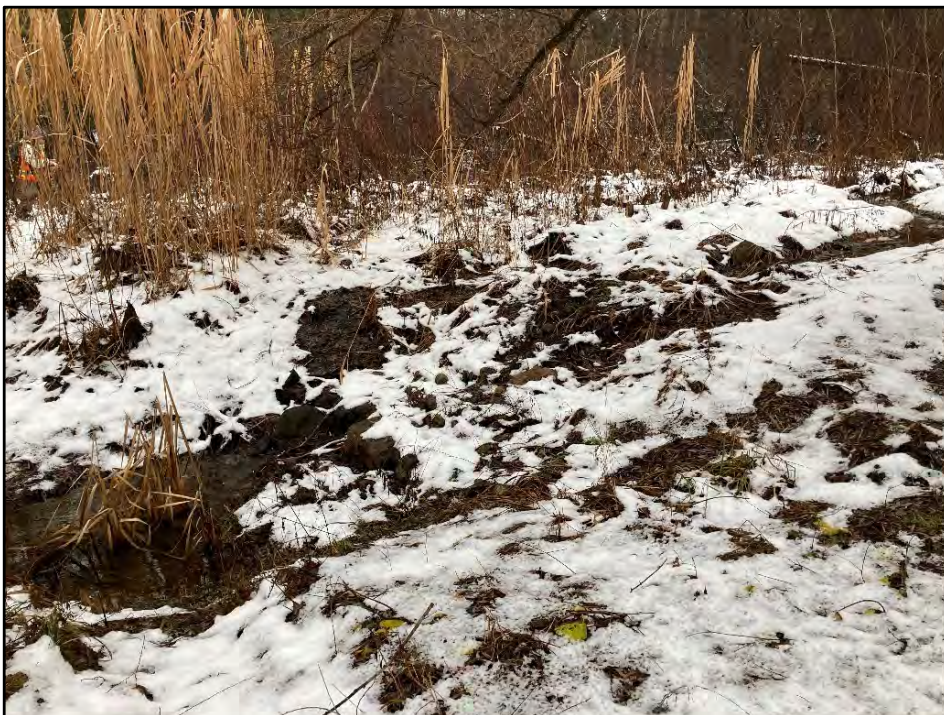
This crossing consists of an embedded CSP culvert. The width is 2,300 mm while the opening height is 1,500 mm, and the structure appears to be in good condition. Substrate within the culvert is fine-grained. The watercourse meanders west of the culvert inlet but there are no current stability concerns. At the inlet of the culvert there is a small hollow which poses a minor risk of potential scour; however, this area is currently stable. Several boulders have been placed in the channel on the outer bank of the meander near the inlet, and the road embankment is stabilized with riprap and vegetation. The west creek bank is entrenched. At the outlet, the channel is backwatered by vegetation and the channel bed is stable with mud deposits. From the outlet the channel meanders slightly to the west. Approximately 50 m downstream of the crossing, there is a drop in channel elevation of 1.5 m that is armoured with stone.

34. Reach T3-R1: 1.5m drop in channel bed elevation.

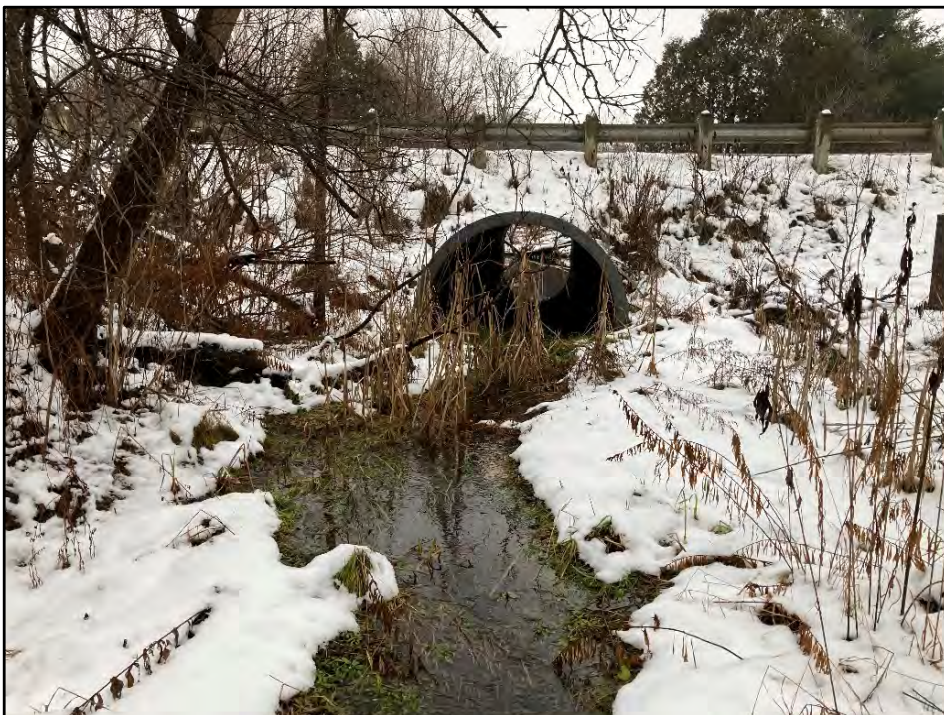
36. Outlet of Crossing 3, reach T3-R1.

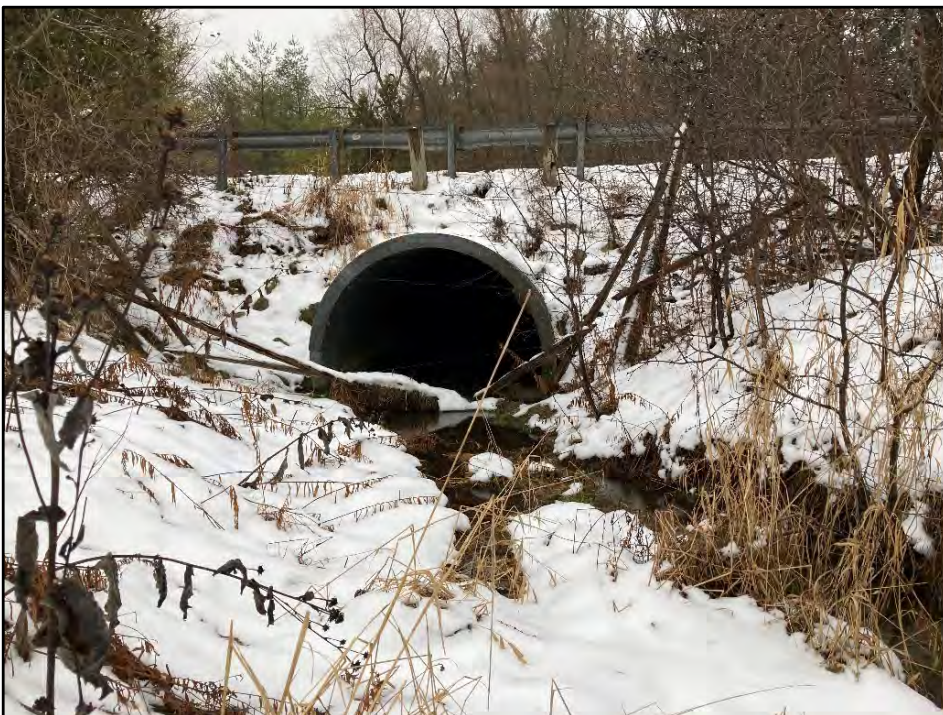
38. Crossing 3 inlet, looking downstream. Channel approaches inlet from the west.
